# Access Compliance Report Public Rights-of-Way (Transit Stops)

| Intersection ID: 10037051 | Main Street: S_TRYON_ST | Cross Street: N/A | Location: E |
| ADA ID: 913AF7316EB6 | Overall Compliance: No | Severity Score: 40 | |

CATS Stop Description: **Tryon St & Arrowood Rd**

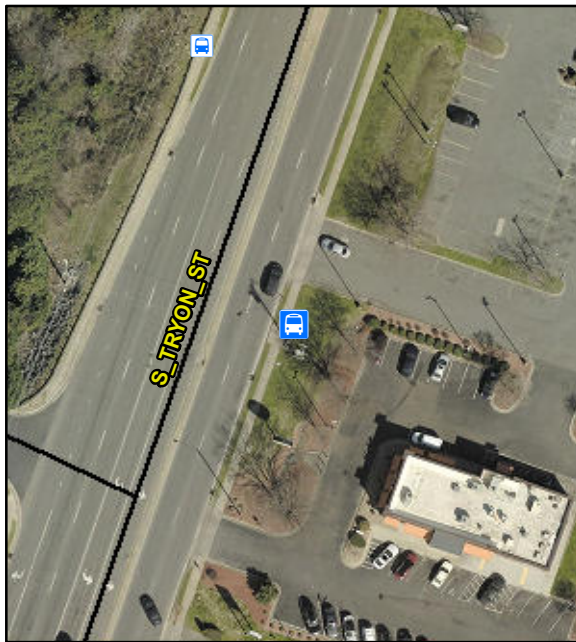
| Compliance | Description | Data |
|---|---|---|
| No | Boarding Area Length (in) | 84.0 |
| No | Boarding Area XSlope % | 2.3 |
| No | PAR 1 XSlope % | 4.5 |

**Remove & Replace Boarding Area.  
Remove & Replace Sidewalk To  
Boarding Area. Provide Clear Floor  
Space. Remove or Relocate  
Protruding Objects/Obstructions.**

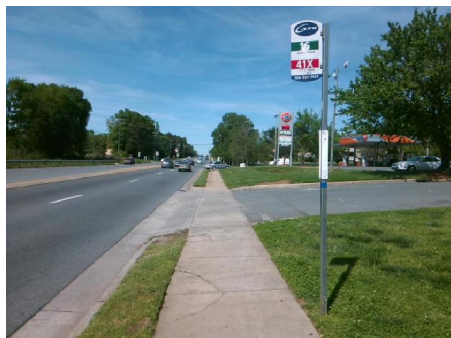
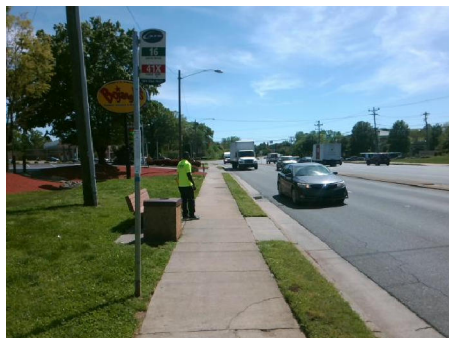
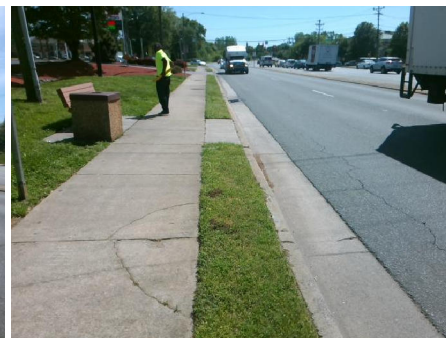
| Compliance | Description | Data |
|---|---|---|
| No | PAR 2 XSlope % | 5.6 |
| No | Clear Floor Space | No |
| No | Protruding Objects? | Yes |
