# Access Compliance Report Public Rights-of-Way (Transit Stops)

| Intersection ID: 10037059 | Main Street: S_TRYON_ST | Cross Street: N/A | Location: NW |
| ADA ID: 93B85C142C68 | Overall Compliance: No | Severity Score: 85 | |

CATS Stop ID: **44905**

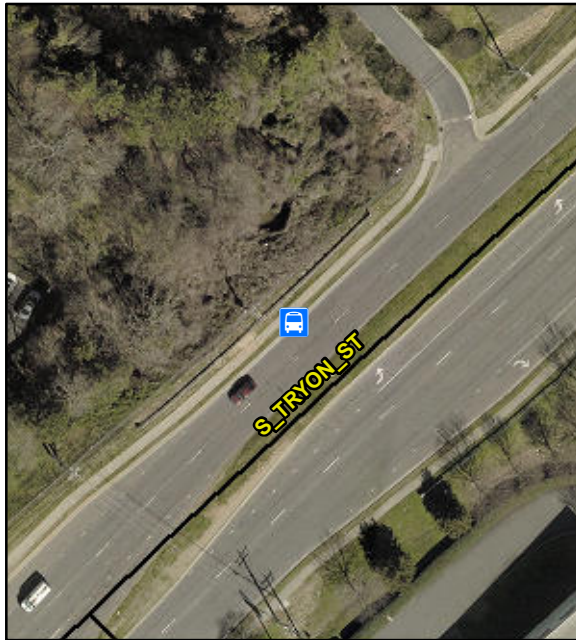
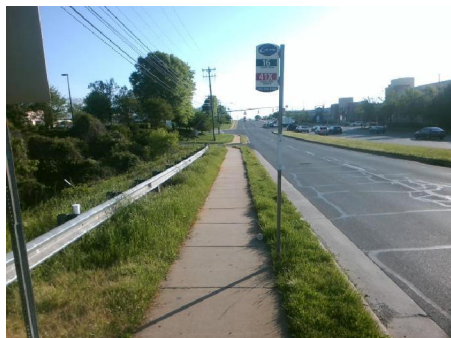
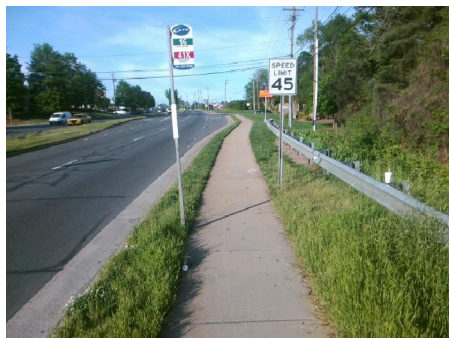
| Compliance | Description | Data |
|---|---|---|
| No | Boarding Area | No |
| No | PAR 1 Exist? | Yes |
| No | PAR 1 Slope % | 3.0 |
| No | PAR 1 XSlope % | 3.8 |
| No | Boarding Area Connected to PAR? | No |

**Provide Boarding Area. Remove & Replace Sidewalk To Boarding Area.**
