# Access Compliance Report Public Rights-of-Way (Transit Stops)

| Intersection ID: N/A | Main Street: E 4TH ST | Cross Street: N/A | Location: E |
| ADA ID: 95E14B14EF82 | Overall Compliance: No | Severity Score: 20 | |

CATS Stop Description: **4th St & Davidson St**

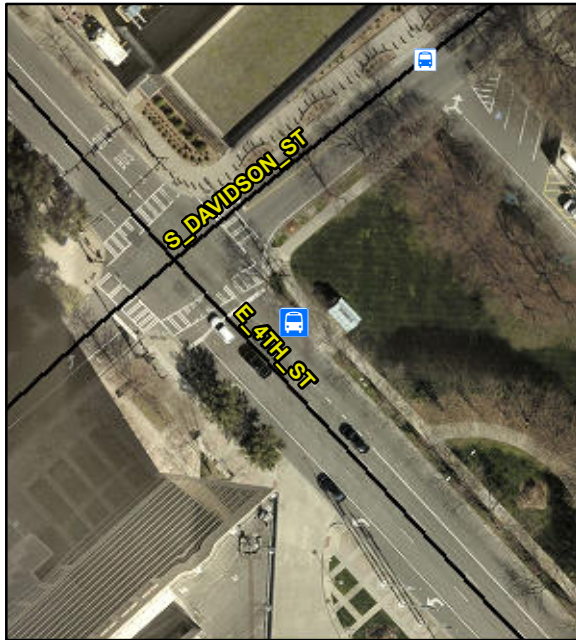
**CATS ID NOT LABELED.**

| Compliance | Description | Data |
|---|---|---|
| No | Boarding Area Slope % | 2.2 |
| No | PAR 1 XSlope % | 2.5 |
| No | PAR 2 Slope % | 3.3 |
| No | Clear Floor Space Slope % | 3.4 |
| No | Protruding Objects? | Yes |

**Remove & Replace Boarding Area.  
Remove & Replace Sidewalk To  
Boarding Area. Remove & Replace  
Clear Floor Space. Remove or  
Relocate Protruding  
Objects/Obstructions.**
