# Access Compliance Report Public Rights-of-Way (Transit Stops)

| Intersection ID: 10026303 | Main Street: FAIRVIEW_RD | Cross Street: WINTERCREST_LN | Location: S |
| ADA ID: 9D12A0E2A7A6 | Overall Compliance: No | Severity Score: 15 | |

CATS Stop Description: Fairview Rd & Wintercrest Ln

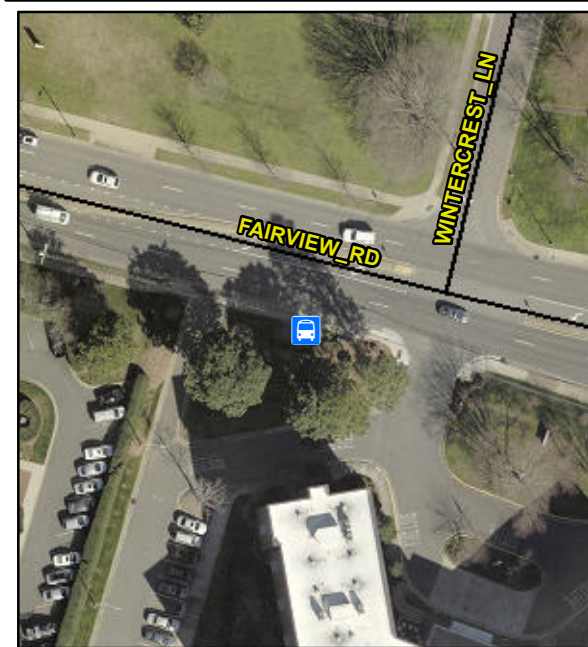
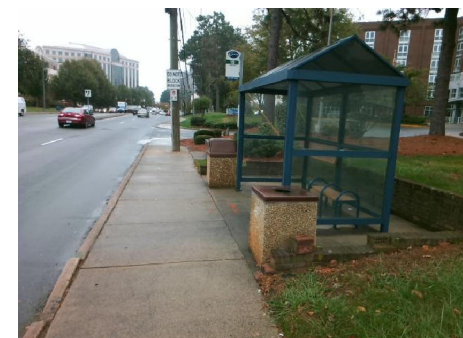
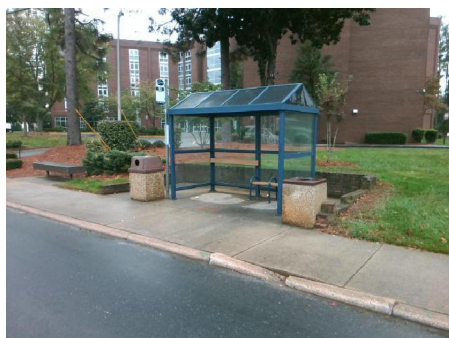
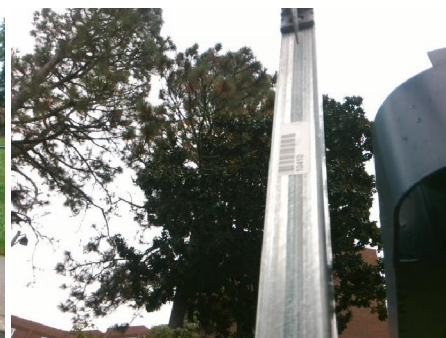
| Compliance | Description | Data |
|---|---|---|
| No | Boarding Area Slope % | 2.1 |
| No | PAR 1 XSlope % | 2.1 |
| No | PAR 2 XSlope % | 4.2 |
| No | Clear Floor Space | Yes |
| No | Clear Floor Space Slope % | 2.1 |
| No | Protruding Objects? | Yes |

**Remove & Replace Boarding Area.  
Remove & Replace Sidewalk To  
Boarding Area. Remove & Replace  
Clear Floor Space. Remove or  
Relocate Protruding  
Objects/Obstructions.**
