# Access Compliance Report Public Rights-of-Way (Transit Stops)

| Intersection ID: 10033993 | Main Street: PARK_RD | Cross Street: N/A | Location: W |
| ADA ID: A0F29929E4A6 | Overall Compliance: No | Severity Score: 50 | |

CATS Stop Description: **Park Rd & Tradewinds Ln**

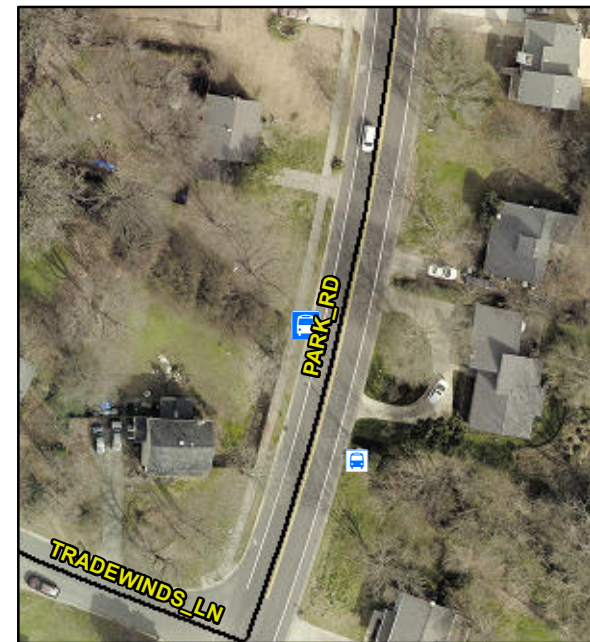
**810.2.4, R308.1.1.2**

| Compliance | Description | Data |
|---|---|---|
| No | Boarding Area Slope % | 4.3 |

**Remove & Replace Boarding Area.**
