# Access Compliance Report Public Rights-of-Way (Transit Stops)

| Intersection ID: 10020503 | Main Street: BARDOT_DR | Cross Street: N/A | Location: E |
| ADA ID: A382EF637E35 | Overall Compliance: No | Severity Score: 100 | |

CATS Stop Description: **Bardot Dr & Dedmon Dr**

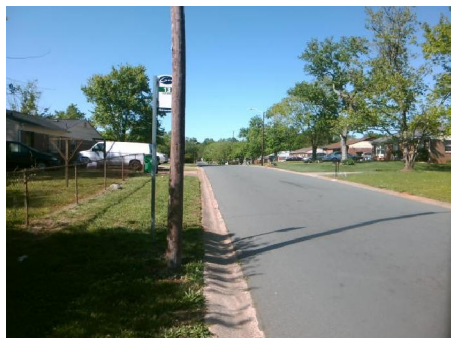
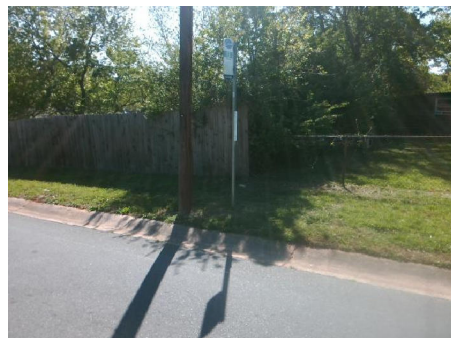
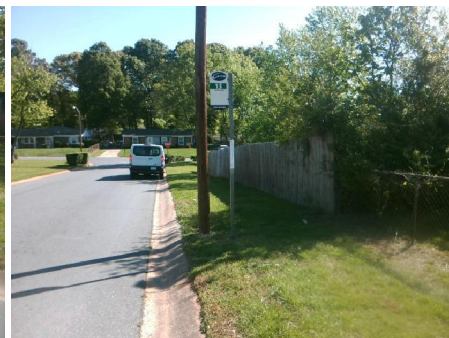
| Compliance | Description | Data |
|---|---|---|
| No | Boarding Area | No |
| No | PAR 1 Exist? | No |
| N/A | Boarding Area Connected to PAR? | No |
| N/A | Road Slope % | 4.8 |
| Yes | Transit Sign? | Yes |
| Yes | Transit Sign Height (in) | 87.0 |

**Provide Boarding Area. Provide Sidewalk To Boarding Area.**
