# Access Compliance Report Public Rights-of-Way (Transit Stops)

| Intersection ID: 10015857 | Main Street: BELMONT_AV | Cross Street: N/A | Location: N |
| ADA ID: AFD2CF94D85B | Overall Compliance: No | Severity Score: 60 | |

CATS Stop Description: **Belmont Ave & Seigle Ave**

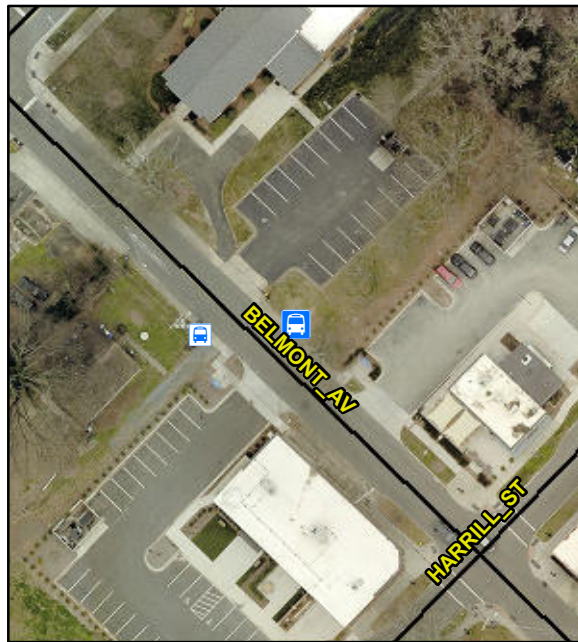
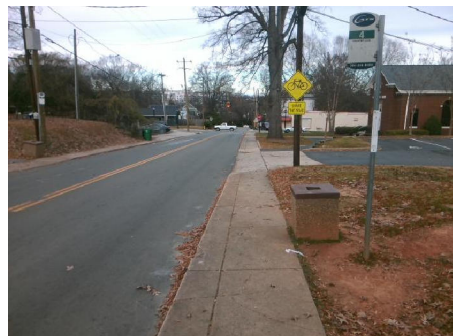
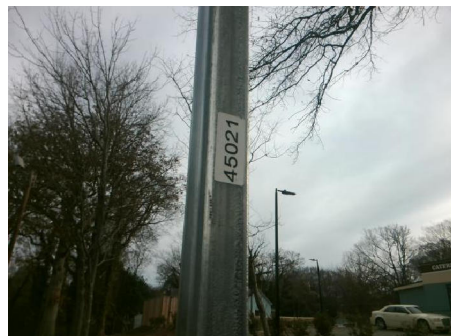
| Compliance | Description | Data |
|---|---|---|
| No | Boarding Area Length (in) | 54.0 |
| No | Boarding Area Slope % | 5.4 |
| No | Boarding Area XSlope % | 6.8 |
| No | PAR 1 Width (in) | 38.0 |
| No | PAR 1 Slope % | 6.8 |
| No | PAR 1 XSlope % | 5.4 |
| No | PAR 2 Width (in) | 38.0 |
| No | PAR 2 Slope % | 6.2 |
| No | PAR 2 XSlope % | 5.2 |
| No | Protruding Objects? | Yes |

**Remove & Replace Boarding Area.  
Remove & Replace Sidewalk To  
Boarding Area. Remove or Relocate  
Protruding Objects/Obstructions.**
