# Access Compliance Report Public Rights-of-Way (Transit Stops)

| Intersection ID: -9999 | Main Street: Catawba Ave | Cross Street: N/A | Location: N |
| ADA ID: B2A0720DFD3A | Overall Compliance: No | Severity Score: 10 | |

CATS Stop Description: Catawba Ave & Ferry St

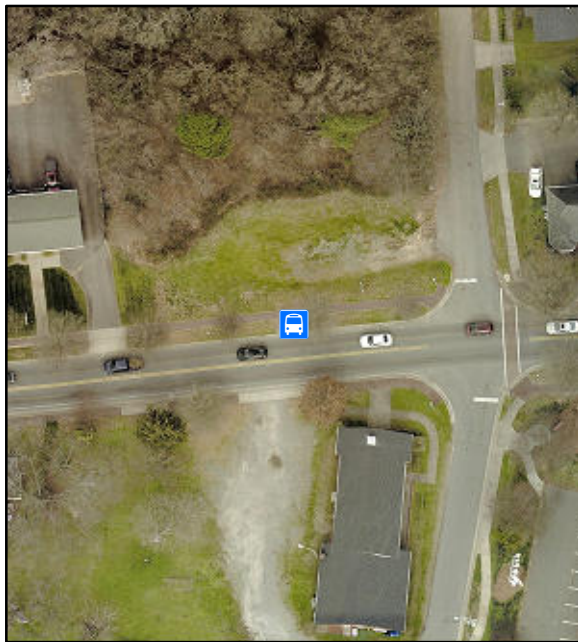
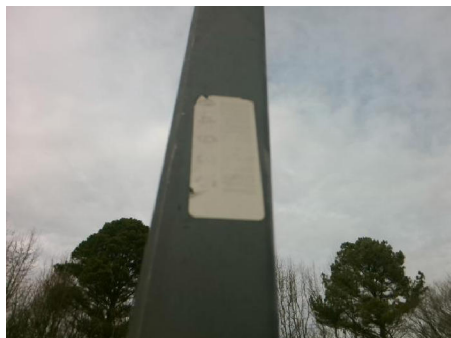
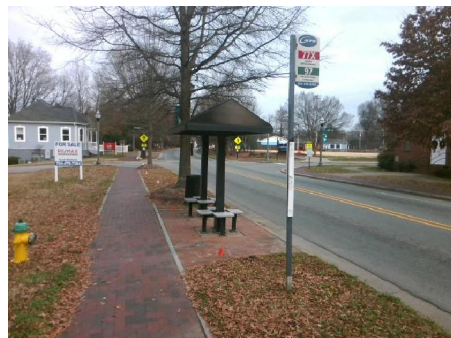
**FADED STICKER**

| Compliance | Description | Data |
|---|---|---|
| No | Clear Floor Space | Yes |
| No | Clear Floor Space XSlope % | 2.6 |
| No | Protruding Objects? | Yes |

**Remove & Replace Clear Floor Space. Remove or Relocate Protruding Objects/Obstructions.**
