# Access Compliance Report Public Rights-of-Way (Transit Stops)

| Intersection ID: 23210 | Main Street: CRESCENT_SPRINGS_DR | Cross Street: S_TRYON_ST | Location: S |
| ADA ID: B46F70A55FF6 | Overall Compliance: No | Severity Score: 85 | |

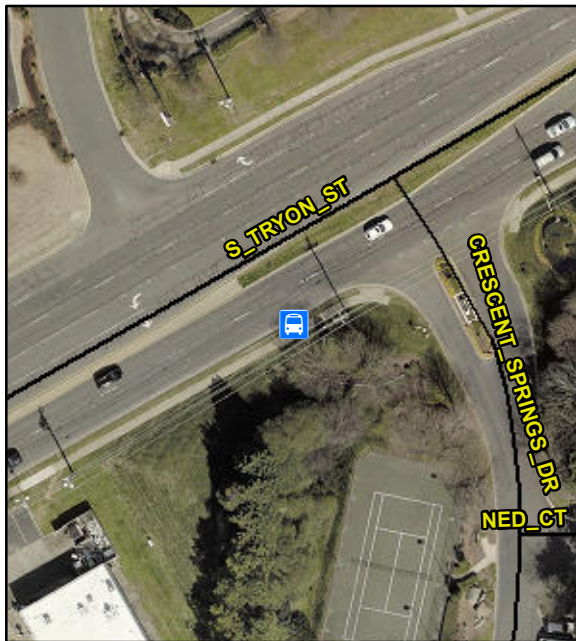
| Compliance | Description | Data |
|---|---|---|
| No | Boarding Area | No |
| No | PAR 1 Exist? | Yes |
| No | PAR 1 XSlope % | 3.0 |
| No | PAR 2 Exist? | Yes |
| No | PAR 2 Slope % | 2.3 |
| No | PAR 2 XSlope % | 3.3 |
| No | Boarding Area Connected to PAR? | No |

**Provide Boarding Area. Remove & Replace Sidewalk To Boarding Area.**
