# Access Compliance Report

## Public Rights-of-Way

### (Transit Stops)

| Intersection ID: 14373 | Main Street: EAST_BV | Cross Street: LYNDHURST_AV | Location: SW |

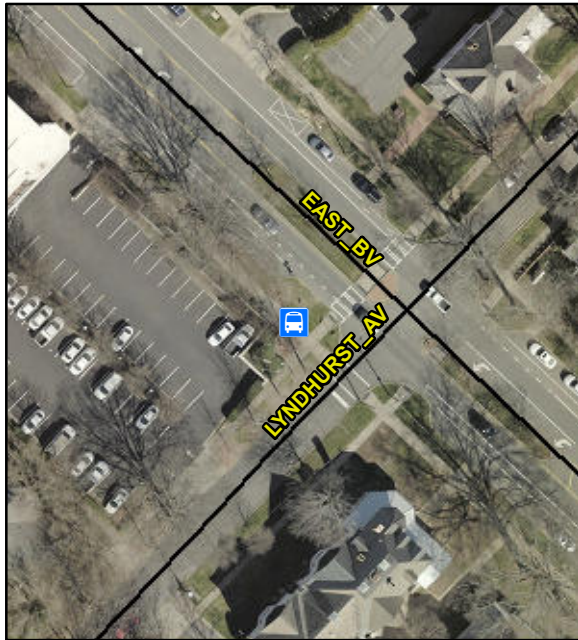
| Compliance | Description | Data |
|---|---|---|
| No | Boarding Area | No |
| No | Boarding Area Connected to PAR? | No |
| No | Clear Floor Space | Yes |
| No | Clear Floor Space Slope % | 3.4 |

**Provide Boarding Area. Provide Sidewalk Connection to Boarding Area. Remove & Replace Clear Floor Space.**
