# Access Compliance Report Public Rights-of-Way (Transit Stops)

| Intersection ID: 10030277 | Main Street: LEAKE_ST | Cross Street: N/A | Location: E |
| ADA ID: BEA00BEC22BE | Overall Compliance: No | Severity Score: 30 | |

CATS Stop ID: **14270**  
CATS Stop Description: **Leake St & West Blvd**  
CATS Route ID: **10**  
CATS Route Name: **West Boulevard**

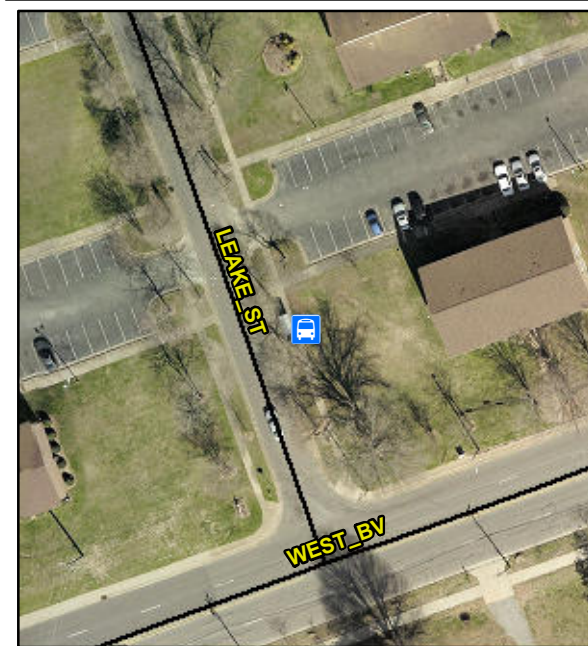
| Compliance | Description | Data |
|---|---|---|
| No | Boarding Area Length (in) | 76.0 |
| No | Boarding Area XSlope % | 5.2 |
| No | PAR 1 Width (in) | 47.5 |
| No | PAR 1 Slope % | 5.6 |
| No | PAR 1 XSlope % | 2.3 |
| No | PAR 2 Width (in) | 47.5 |
| No | PAR 2 Slope % | 3.8 |
| No | Clear Floor Space Slope % | 4.3 |
| No | Clear Floor Space XSlope % | 3.5 |
| No | Protruding Objects? | Yes |

**Remove & Replace Boarding Area.  
Remove & Replace Sidewalk To  
Boarding Area. Remove & Replace  
Clear Floor Space. Remove or  
Relocate Protruding  
Objects/Obstructions.**
