# Access Compliance Report

## Public Rights-of-Way

### (Transit Stops)

| Intersection ID: 12419 | Main Street: OTTS_ST | Cross Street: SEIGLE_AV | Location: W |

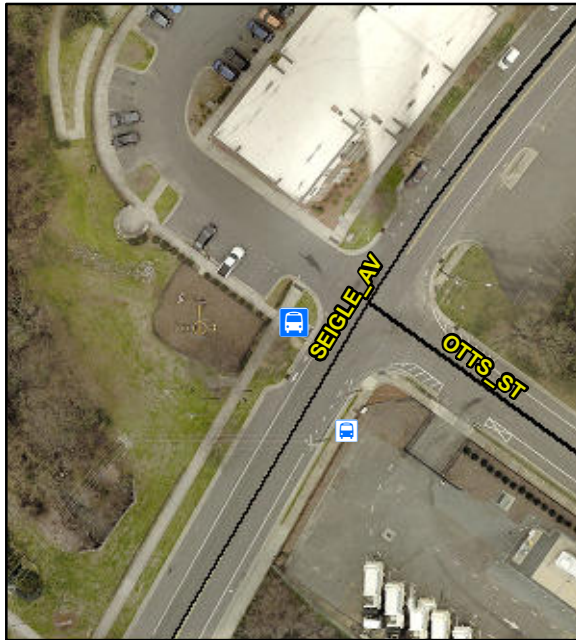
**BOARDING AREA IS WITHIN CURB  
RAMP, MEASURED BOARDING  
NEXT TO SIGN**

**Remove & Replace Boarding Area.  
Remove & Replace Sidewalk To  
Boarding Area. Provide Clear Floor  
Space.**

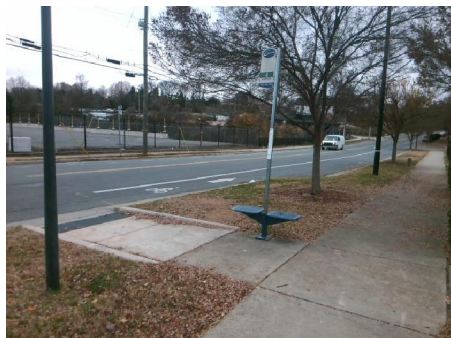
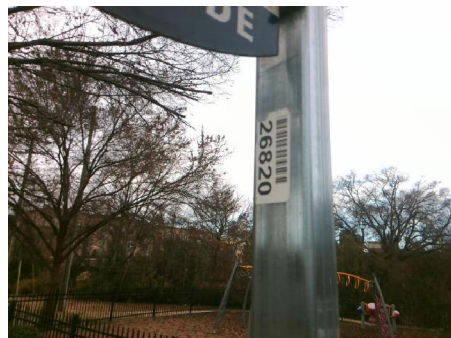
| Compliance | Description | Data |
|---|---|---|
| No | Boarding Area Slope % | 5.0 |
| No | PAR 1 XSlope % | 2.3 |
| No | PAR 2 XSlope % | 3.1 |
| No | Clear Floor Space | No |
