# Access Compliance Report Public Rights-of-Way (Transit Stops)

| Intersection ID: 10035052 | Main Street: PROVIDENCE_RD | Cross Street: N/A | Location: NE |
| ADA ID: CAB7BC2D474D | Overall Compliance: No | Severity Score: 80 | |

CATS Stop Description: **Providence Rd & Westbury Rd**

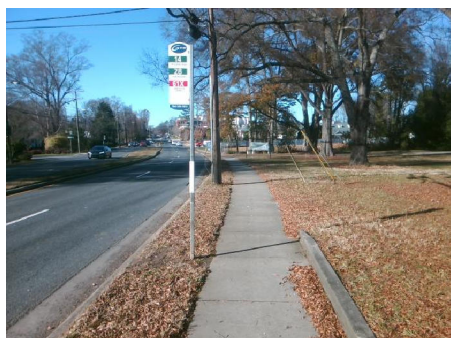
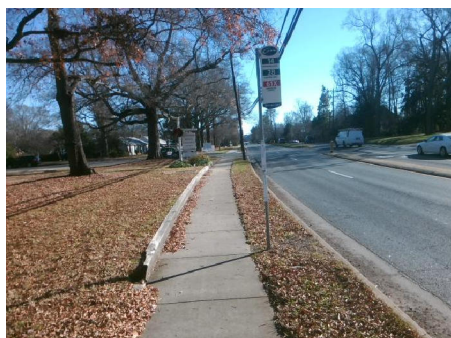
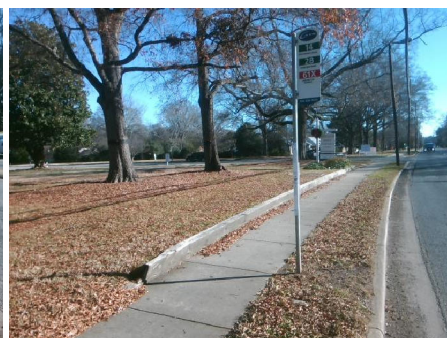
| Compliance | Description | Data |
|---|---|---|
| No | Boarding Area | No |
| No | Boarding Area Connected to PAR? | No |

**Provide Boarding Area. Provide Sidewalk Connection to Boarding Area.**
