# Access Compliance Report Public Rights-of-Way (Transit Stops)

| Intersection ID: 10026323 | Main Street: FAIRVIEW_RD | Cross Street: N/A | Location: NW |
| ADA ID: CCE17A58D308 | Overall Compliance: No | Severity Score: 80 | |

CATS Stop Description: **Fairview Rd & Providence Rd**

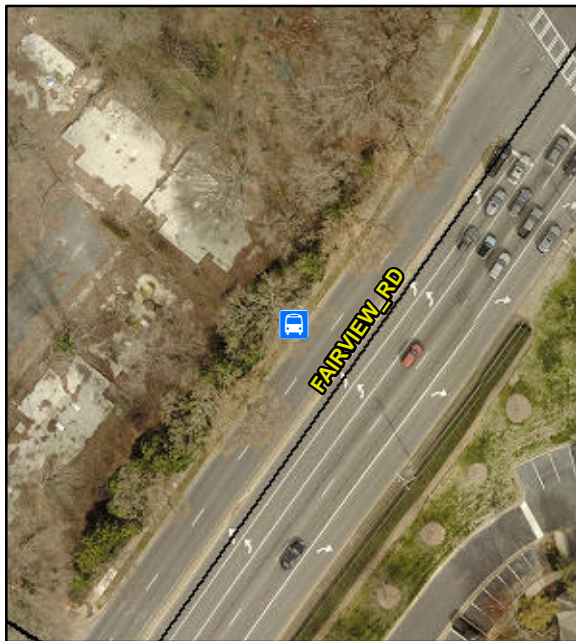
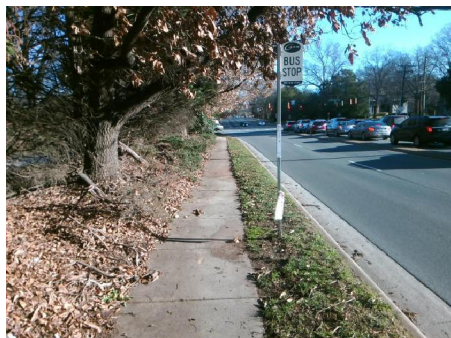
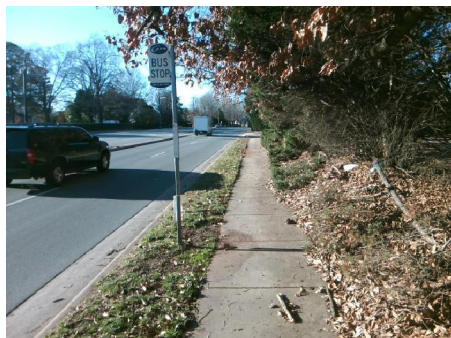
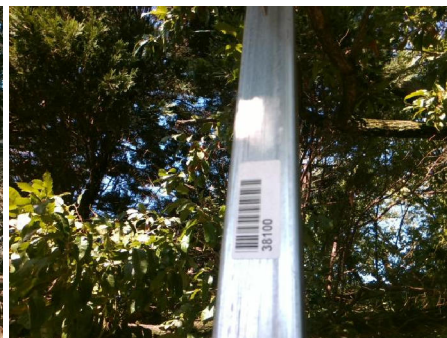
**STOP NOT IN SERVICE**

| Compliance | Description | Data |
|---|---|---|
| No | Boarding Area | No |
| No | PAR 1 Exist? | Yes |
| No | PAR 1 XSlope % | 2.1 |
| No | Boarding Area Connected to PAR? | No |

Possible Solutions:

**Provide Boarding Area. Remove & Replace Sidewalk To Boarding Area.**
