# Access Compliance Report Public Rights-of-Way (Transit Stops)

| Intersection ID: 10038367 | Main Street: SOUTH_BV | Cross Street: N/A | Location: E |
| ADA ID: D64509F469A2 | Overall Compliance: No | Severity Score: 10 | |

CATS Stop Description: South Blvd & Starbrook Dr

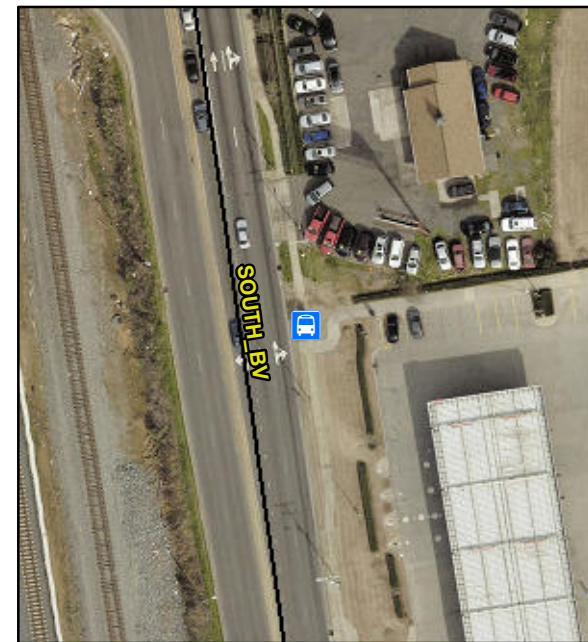
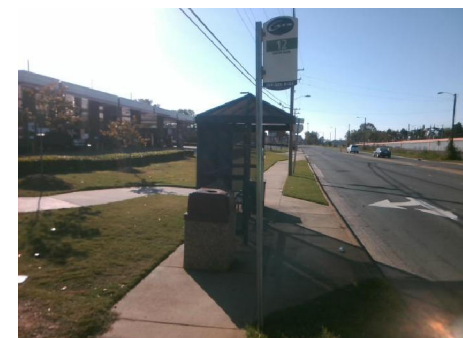
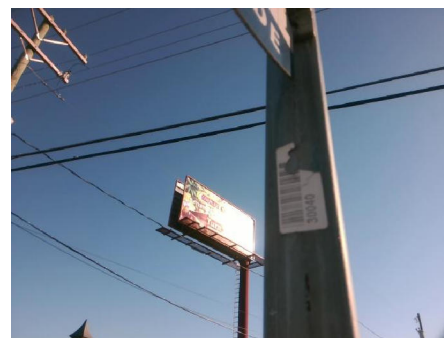
| Compliance | Description | Data |
|---|---|---|
| No | Clear Floor Space | Yes |
| No | Clear Floor Space Slope % | 2.9 |
| No | Protruding Objects? | Yes |

**Remove & Replace Clear Floor Space. Remove or Relocate Protruding Objects/Obstructions.**
