# Access Compliance Report Public Rights-of-Way (Transit Stops)

| Intersection ID: 10037031 | Main Street: S_TRYON_ST | Cross Street: N/A | Location: E |
| ADA ID: D6AD6C536F6F | Overall Compliance: No | Severity Score: 5 | |

CATS Stop Description: **Tryon St & Yorkmont Rd**

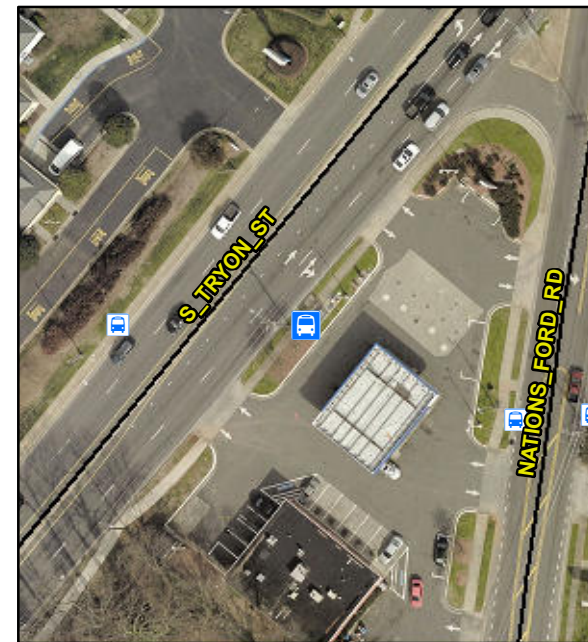
| Compliance | Description | Data |
|---|---|---|
| No | Boarding Area Length (in) | 35.0 |
| No | Protruding Objects? | Yes |

**Remove & Replace Boarding Area.  
Remove or Relocate Protruding  
Objects/Obstructions.**
