# Access Compliance Report Public Rights-of-Way (Transit Stops)

| Intersection ID: 10020901 | Main Street: BELLHAVEN_BV | Cross Street: N/A | Location: E |
| ADA ID: D8CD1E0C76D4 | Overall Compliance: No | Severity Score: 45 | |

CATS Stop Description: Bellhaven Blvd & Rozwood Dr

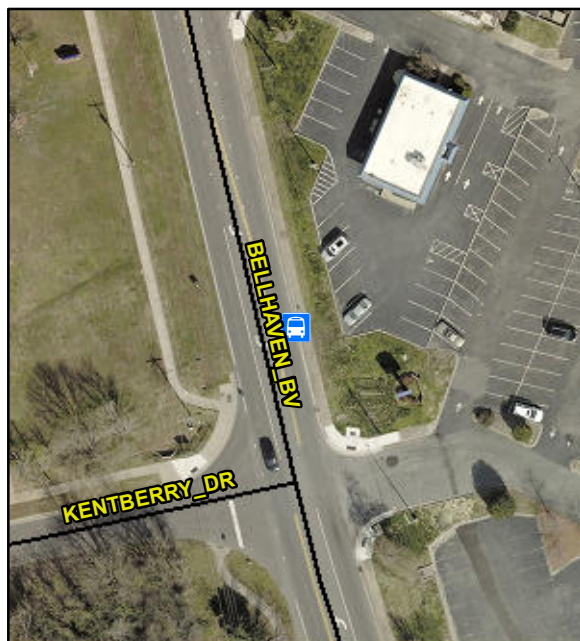
| Compliance | Description | Data |
|---|---|---|
| No | Boarding Area Length (in) | 66.0 |
| No | Boarding Area Slope % | 2.3 |
| No | PAR 1 Exist? | Yes |
| No | PAR 1 XSlope % | 2.3 |

**Remove & Replace Boarding Area.  
Remove & Replace Sidewalk To  
Boarding Area.**
