# Access Compliance Report Public Rights-of-Way (Transit Stops)

| Intersection ID: 10013227 | Main Street: THE_PLAZA | Cross Street: N/A | Location: N |
| ADA ID: D8FBEA41D874 | Overall Compliance: No | Severity Score: 30 | |

CATS Stop Description: **The Plaza & Fairmarket PI**

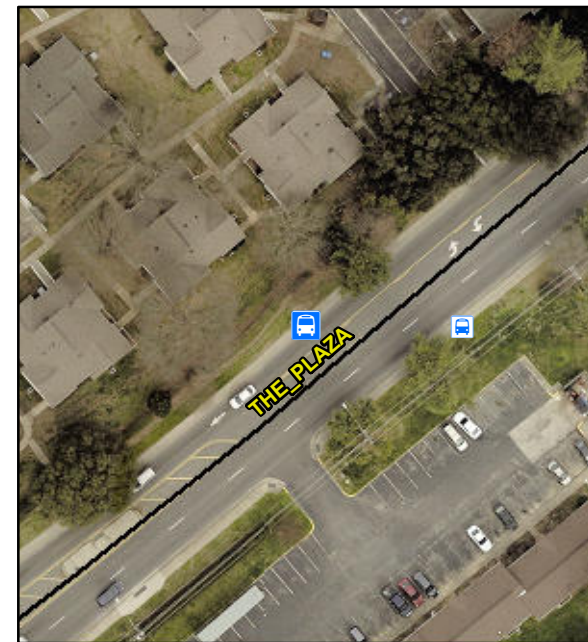
| Compliance | Description | Data |
|---|---|---|
| No | Boarding Area Length (in) | 54.0 |
| No | Boarding Area Slope % | 4.7 |
| No | PAR 1 XSlope % | 4.7 |
| No | PAR 2 XSlope % | 4.6 |
| No | Clear Floor Space Width (in) | 24.0 |
| No | Clear Floor Space Length (in) | 36.0 |
| No | Clear Floor Space Slope % | 8.4 |
| No | Protruding Objects? | Yes |

**Remove & Replace Boarding Area.  
Remove & Replace Sidewalk To  
Boarding Area. Remove & Replace  
Clear Floor Space. Remove or  
Relocate Protruding  
Objects/Obstructions.**

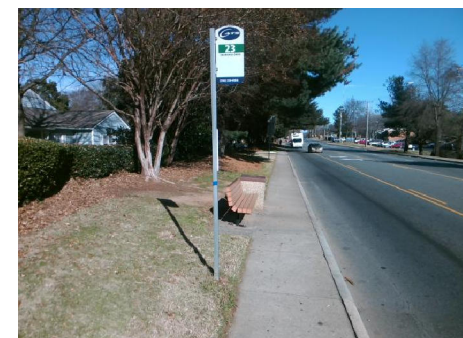
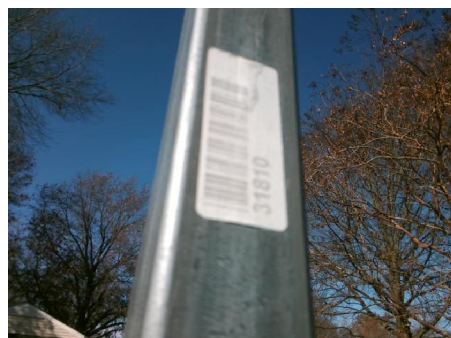
| Compliance | Description | Data |
|---|---|---|
| No | Clear Floor Space | Yes |
