# Access Compliance Report Public Rights-of-Way (Transit Stops)

| Intersection ID: 10035064 | Main Street: PROVIDENCE_RD | Cross Street: N/A | Location: SE |
| ADA ID: D9F7D5FC326E | Overall Compliance: No | Severity Score: 45 | |

CATS Stop Description: **Providence Rd & Creola Rd**

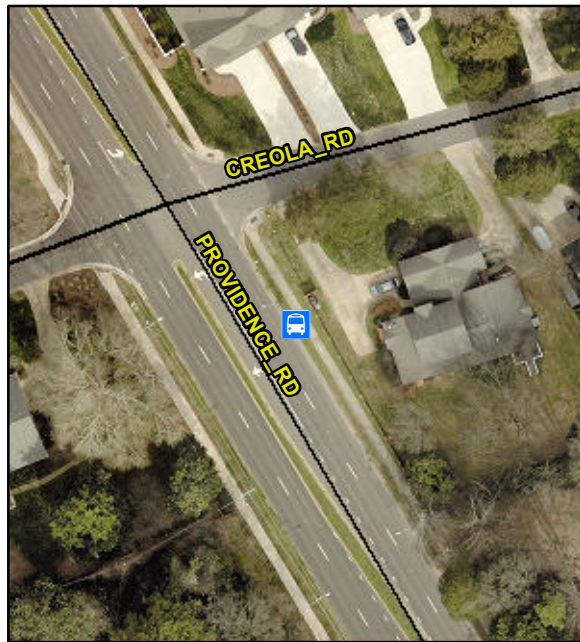
**810.2.4, R308.1.1.2**

| Compliance | Description | Data |
|---|---|---|
| No | Boarding Area Slope % | 2.4 |
| No | Boarding Area XSlope % | 2.3 |

**Remove & Replace Boarding Area.**
