# Access Compliance Report Public Rights-of-Way (Transit Stops)

| Intersection ID: 10031170 | Main Street: MARION_DIEHL_PARK_DR | Cross Street: N/A | Location: E |
| ADA ID: DCAB2D661AD6 | Overall Compliance: No | Severity Score: 70 | |

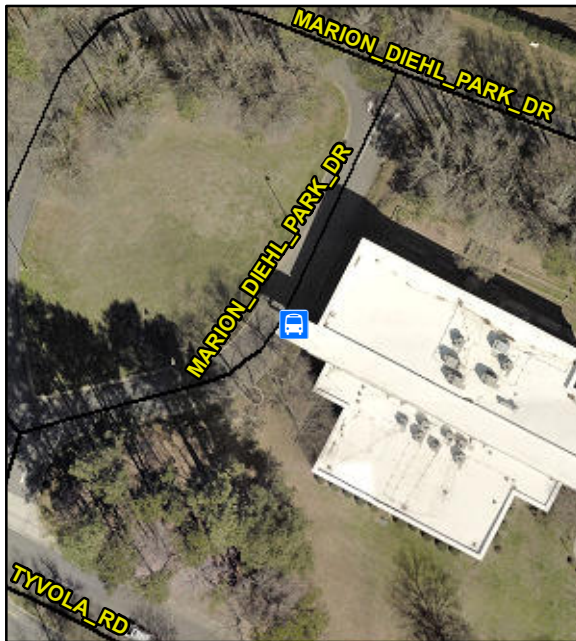
**TRANSIT STOP LOCATED IN  
BUILDING ENTRANCE, NO CATS ID  
LISTED**

| Compliance | Description | Data |
|---|---|---|
| No | Boarding Area Slope % | 9.0 |
| No | PAR 1 Exist? | No |

**Remove & Replace Boarding Area.  
Provide Sidewalk To Boarding Area.  
Adjust Transit Stop Sign Height.**

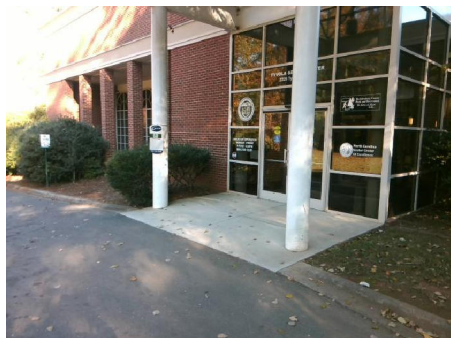
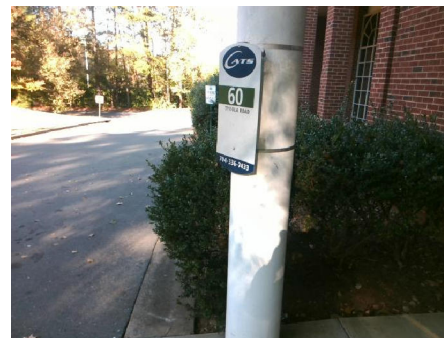
| Compliance | Description | Data |
|---|---|---|
| No | Transit Sign Height (in) | 47.0 |
