# Access Compliance Report

## Public Rights-of-Way

### (Transit Stops)

| Intersection ID: 10619 | Main Street: MARTIN_ST | Cross Street: W_5TH_ST | Location: S |

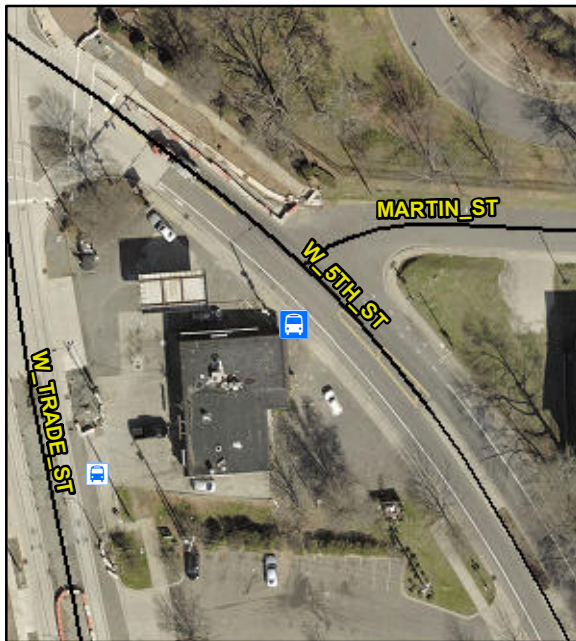
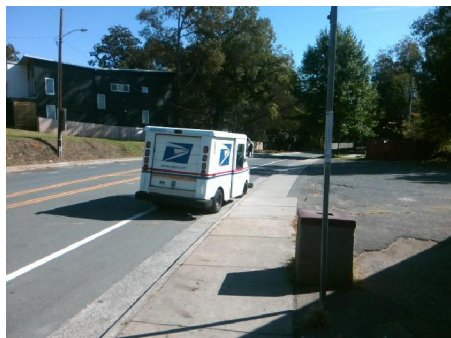
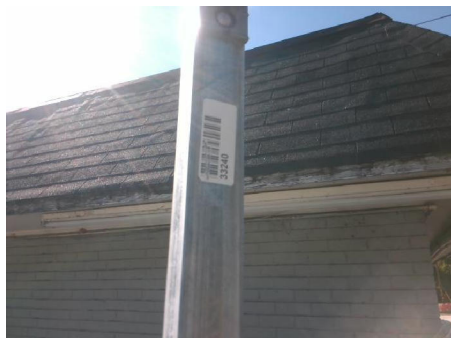
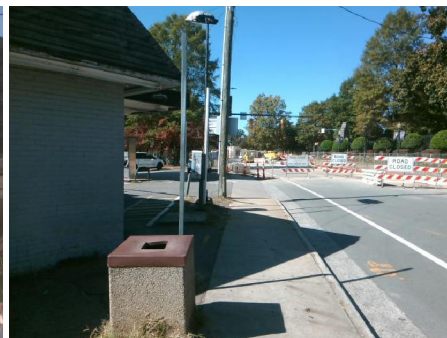
| Compliance | Description | Data |
|---|---|---|
| No | Boarding Area Length (in) | 66.0 |
| No | Boarding Area Slope % | 3.5 |
| No | PAR 1 XSlope % | 3.5 |
| No | Protruding Objects? | Yes |

**Remove & Replace Boarding Area.  
Remove & Replace Sidewalk To  
Boarding Area. Remove or Relocate  
Protruding Objects/Obstructions.**
