# Access Compliance Report Public Rights-of-Way (Transit Stops)

| Intersection ID: 10035037 | Main Street: PROVIDENCE_RD | Cross Street: N/A | Location: W |
| ADA ID: E24BAF92ADE9 | Overall Compliance: No | Severity Score: 80 | |

CATS Stop Description: **Providence Rd & Hanson Dr**

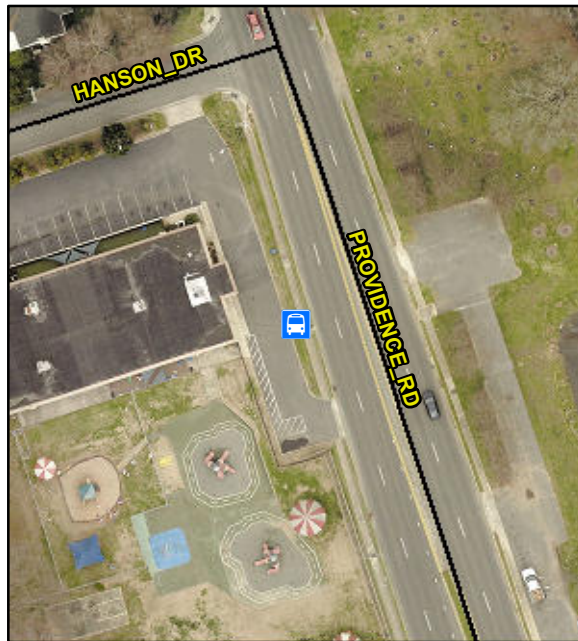
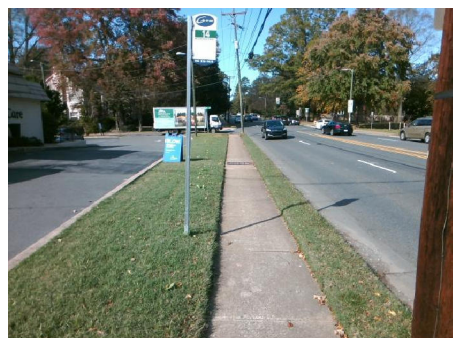
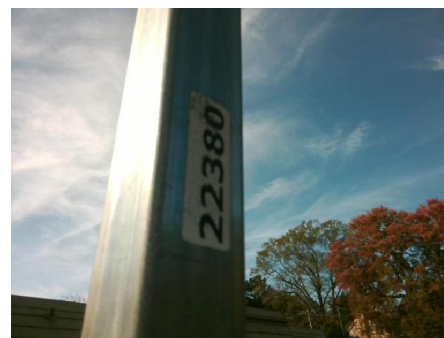
| Compliance | Description | Data |
|---|---|---|
| No | Boarding Area | No |
| No | PAR 1 Exist? | Yes |
| No | PAR 1 XSlope % | 3.2 |
| No | Boarding Area Connected to PAR? | No |

**Provide Boarding Area. Remove & Replace Sidewalk To Boarding Area.**
