# Access Compliance Report Public Rights-of-Way (Transit Stops)

| Intersection ID: 10040736 | Main Street: W_TRADE_ST | Cross Street: N/A | Location: E |
| ADA ID: E3709B122DF5 | Overall Compliance: No | Severity Score: 45 | |

CATS Stop ID: **33842**  
CATS Stop Description: **Trade St & 5th St**  
CATS Route ID: **7**  
CATS Route Name: **Beatties Ford**

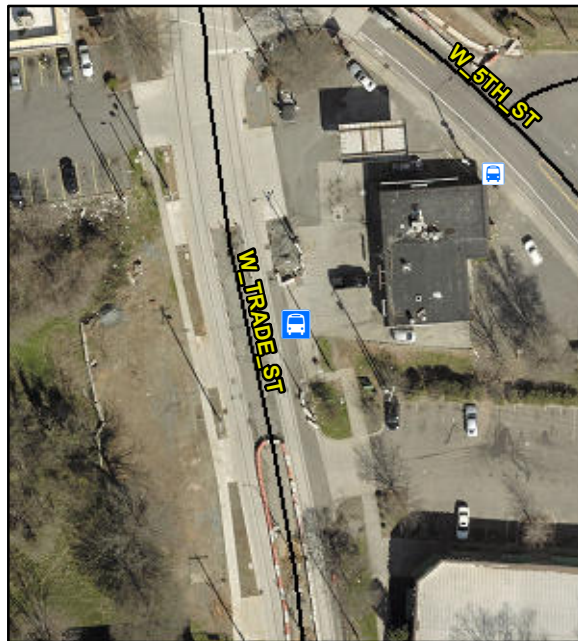
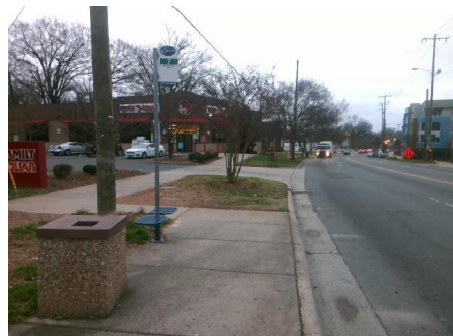
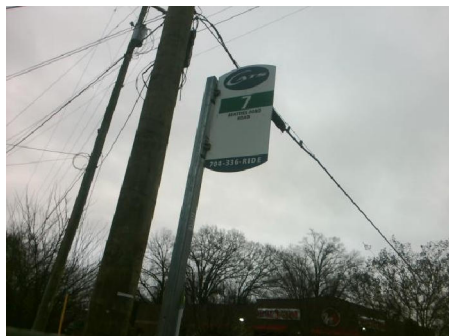
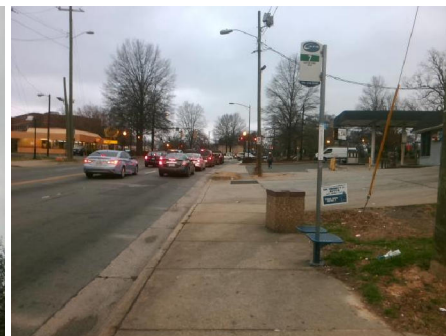
| Compliance | Description | Data |
|---|---|---|
| No | Boarding Area Slope % | 2.8 |
| No | PAR 1 Exist? | Yes |
| No | PAR 1 XSlope % | 2.8 |
| No | Clear Floor Space | No |
| No | Protruding Objects? | Yes |

**Remove & Replace Boarding Area.  
Remove & Replace Sidewalk To  
Boarding Area. Provide Clear Floor  
Space. Remove or Relocate  
Protruding Objects/Obstructions.**
