# Access Compliance Report Public Rights-of-Way (Transit Stops)

| Intersection ID: 10038413 | Main Street: SOUTH_POINT_BV | Cross Street: N/A | Location: N |
| ADA ID: E62ECA9918E1 | Overall Compliance: No | Severity Score: 55 | |

CATS Stop Description: **South Point Blvd & Carowinds Blvd**

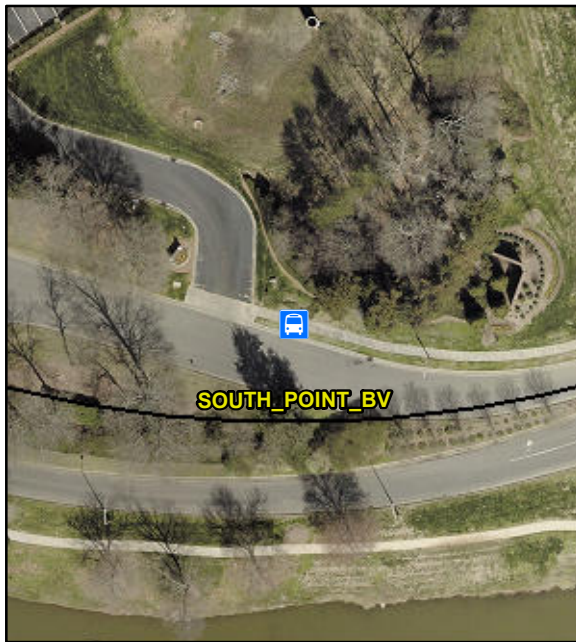
| Compliance | Description | Data |
|---|---|---|
| No | Boarding Area Width (in) | 58.5 |
| No | Boarding Area Slope % | 3.9 |
| No | Boarding Area XSlope % | 2.9 |
| No | PAR 1 Slope % | 2.3 |
| No | PAR 2 Slope % | 2.4 |

**Remove & Replace Boarding Area.  
Remove & Replace Sidewalk To  
Boarding Area.**
