# Access Compliance Report Public Rights-of-Way (Transit Stops)

| Intersection ID: 10015275 | Main Street: HARRIS_CORNERS_PY | Cross Street: N/A | Location: W |
| ADA ID: E86086212AC0 | Overall Compliance: No | Severity Score: 15 | |

CATS Stop ID: 46412

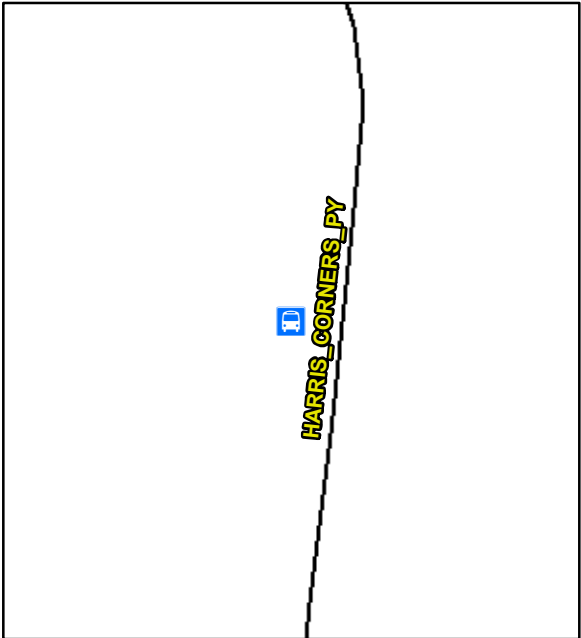
<table><tr> <th>Compliance</th><th>Description</th><th>Data</th></tr><tr><td>No</td><td>Boarding Area Width (in)</td><td>48.0</td></tr><tr><td>No</td><td>Boarding Area Slope %</td><td>3.4</td></tr><tr><td>No</td><td>PAR 1 XSlope %</td><td>3.4</td></tr><tr><td>No</td><td>PAR 2 XSlope %</td><td>3.0</td></tr><tr><td>No</td><td>Protruding Objects?</td><td>Yes</td></tr></table>

| <p>Possible Solutions:</p> <p><b>Remove &amp; Replace Boarding Area.<br/>Remove &amp; Replace Sidewalk To<br/>Boarding Area. Remove or Relocate<br/>Protruding Objects/Obstructions.</b></p> <p>Surveyor Notes:</p> <p><b>N/A</b></p> <p>PROW/ADA:</p> <p><b>402.2, 810.2.2, 810.2.3, 810.2.4, R302,<br/>R302.5, R302.6, R308.1.1.1,<br/>R308.1.1.2</b></p> |

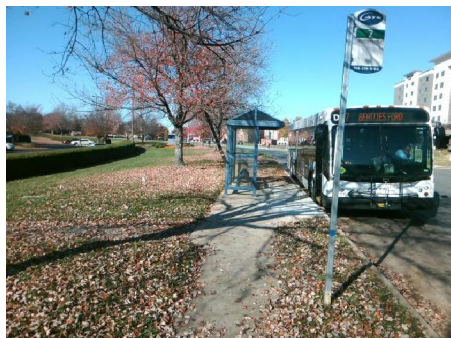
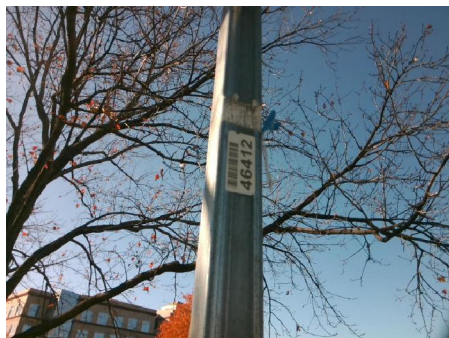
<table><tr> <th>Compliance</th><th>Description</th><th>Data</th></tr><tr><td>No</td><td>PAR 1 Exist?</td><td>Yes</td></tr><tr><td>No</td><td>PAR 2 Exist?</td><td>Yes</td></tr></table>
