# Access Compliance Report

## Public Rights-of-Way

### (Transit Stops)

| Intersection ID: 10040526 | Main Street: W_5TH_ST | Cross Street: N_CEDAR_ST | Location: N |

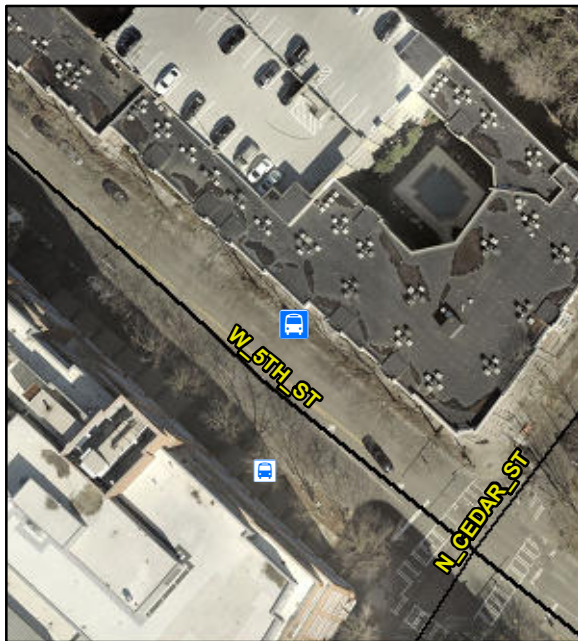
| Compliance | Description | Data |
|---|---|---|
| No | Boarding Area Slope % | 6.6 |
| No | PAR 1 Exist? | Yes |
| No | PAR 1 Slope % | 3.1 |
| No | PAR 1 XSlope % | 2.1 |
| No | PAR 2 Exist? | Yes |
| No | PAR 2 Slope % | 2.5 |

**Remove & Replace Boarding Area.  
Remove & Replace Sidewalk To  
Boarding Area.**
