# Access Compliance Report Public Rights-of-Way (Transit Stops)

| Intersection ID: 10031961 | Main Street: MONROE_RD | Cross Street: N/A | Location: NE |
| ADA ID: F28DF0011F0E | Overall Compliance: No | Severity Score: 45 | |

CATS Stop Description: Monroe Rd & Eaton Rd

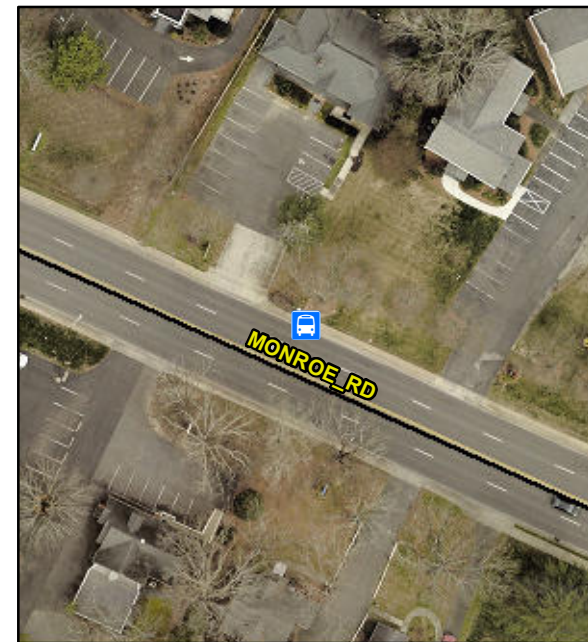
| Compliance | Description | Data |
|---|---|---|
| No | Boarding Area Length (in) | 54.0 |
| No | Boarding Area Slope % | 3.9 |
| No | PAR 1 XSlope % | 4.0 |
| No | PAR 2 XSlope % | 3.8 |

**Remove & Replace Boarding Area.  
Remove & Replace Sidewalk To  
Boarding Area.**
