# Access Compliance Report

## Public Rights-of-Way

### (Transit Stops)

| Intersection ID: 19071 | Main Street: S_TRYON_ST | Cross Street: LAND_GRANT_RD | Location: S |

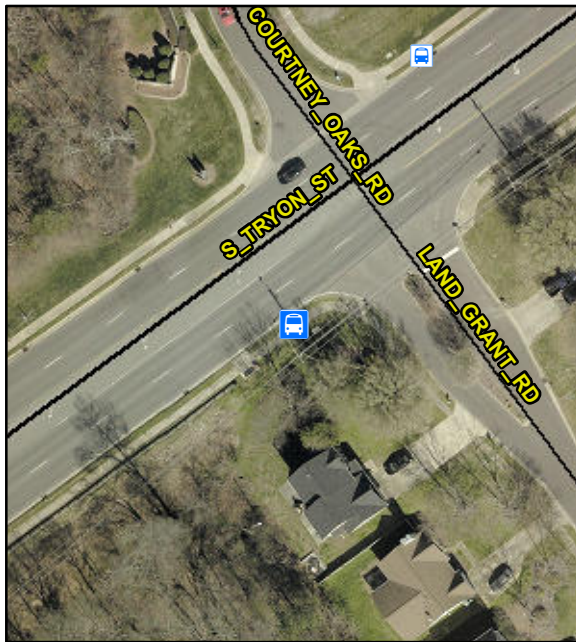
Surveyor Notes:

**N/A**

| Compliance | Description | Data |
|---|---|---|
| No | Boarding Area | No |
| No | Boarding Area Connected to PAR? | No |

**Provide Boarding Area. Provide Sidewalk Connection to Boarding Area. Provide Clear Floor Space. Remove or Relocate Protruding Objects/Obstructions.**

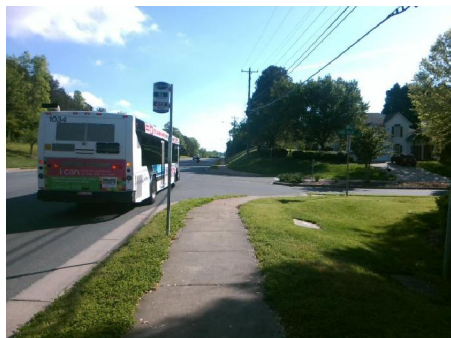
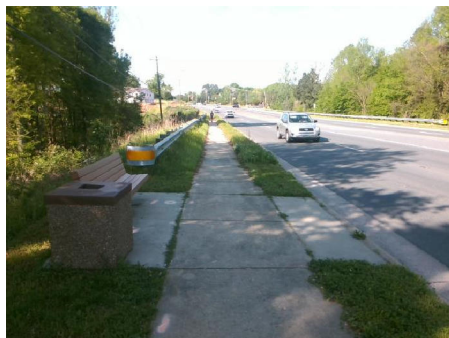
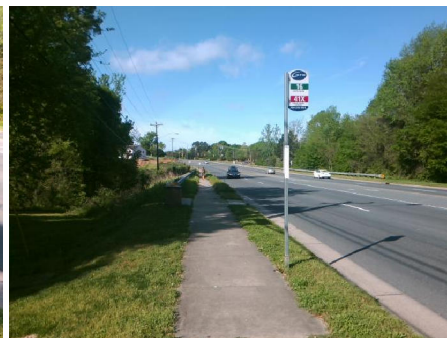
| Compliance | Description | Data |
|---|---|---|
| No | Clear Floor Space | No |
| No | Protruding Objects? | Yes |
