# Access Compliance Report Public Rights-of-Way (Transit Stops)

| Intersection ID: 1001295 | Main Street: RESEARCH_DR | Cross Street: N/A | Location: N |
| ADA ID: F3C749C01D03 | Overall Compliance: No | Severity Score: 100 | |

CATS Stop ID: **49910**  
 CATS Stop Description: **Research Drive @ 9700**  
 CATS Route ID: **50, 54**  
 CATS Route Name: **Multiple**

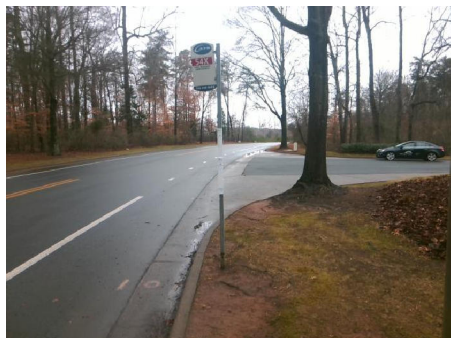
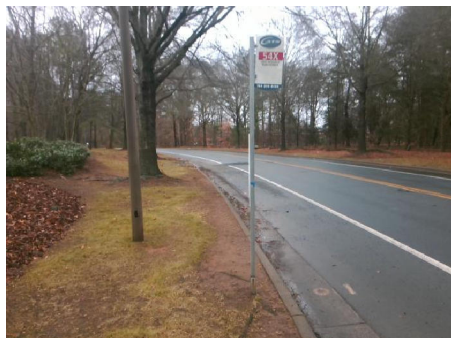
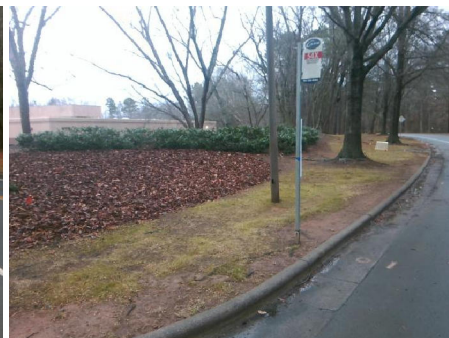
| Compliance | Description | Data |
|---|---|---|
| No | Boarding Area | No |
| No | PAR 1 Exist? | No |
| N/A | Boarding Area Connected to PAR? | No |
| Yes | Transit Sign? | Yes |
| Yes | Transit Sign Height (in) | 95.0 |

**Provide Boarding Area. Provide Sidewalk To Boarding Area.**
