Access Compliance Report

Public Rights-of-Way

(Accessible Street Parking)

Intersection ID: 10022318	Main Street: CAMDEN_RD	Location:	N/A
ADA ID: 06836CE4DF5E	ParkingType: ParaPark	Overall Compliance: No	Severity Score: 0.0
Codes/Mitigation Info/Possible Solution		Field Measurements/Component Compliance

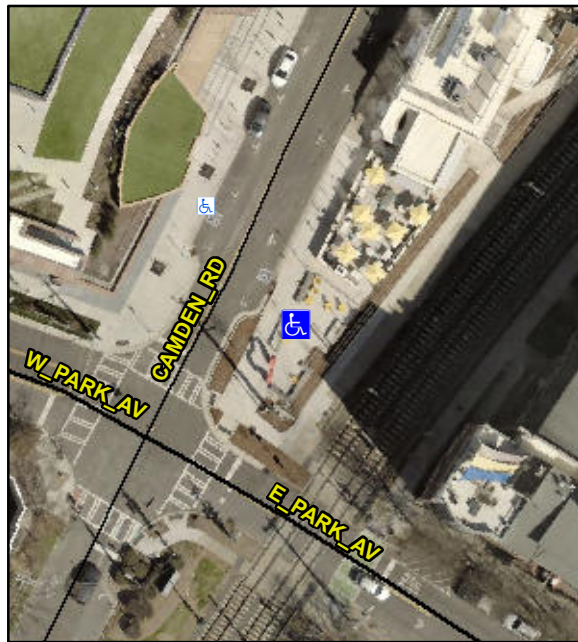
Compliance	Description	Data	Compliance	Description	Data
N/A	Parking Spot At End of Block?	Yes	Yes	Accessible Route?	Yes
Yes	Adjacent Sidewalk Width (in)	120.0	No	Access Aisle Marking?	No
Yes	Adjacent Sidewalk Slope (%)	0.0	N/A	Access Aisle Width (in)	N/A
Yes	Adjacent Sidewalk XSlope (%)	0.3	N/A	Access Aisle Length (in)	N/A
Yes	Adjacent Sidewalk Clear of Obstr.	Yes	N/A	Access Aisle Location	N/A
	N/A	Parking Spot Width (in)		79.0	
	N/A	Parking Spot Length (in)		319.0	
	N/A	Van Accessible?		N/A	
	No	Curb Ramp?		No	
	N/A	Identification Sign?		N/A	
	N/A	Sign Height (in)		N/A	
	N/A	Vertical Clearance		N/A	
	N/A	Parking Meter?		N/A	
	N/A	Parking Meter Height (in)		N/A	
	N/A	Meter Operable Parts?		N/A	
	N/A	Meter Clear Space?		N/A	
	N/A	Meter Clear Space Slope (%)		N/A	
	N/A	Meter Clear Space XSlope (%)		N/A	
	N/A	Meter Forward Reach?		N/A	
	N/A	Meter Forward Reach (in)		N/A	
	N/A	Meter Parallel Reach?		N/A	
	N/A	Meter Parallel Reach (in)		N/A

Advise relocating to an area with maximum 2% slopes

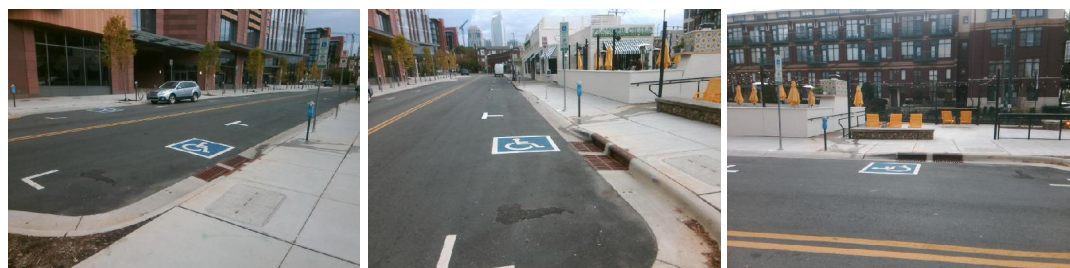
N/A	Parking Space/Access Aisle Slopes (%)						
C Slope (%)	0.9	D Slope (%)	0.7	I Slope (%)	N/A	L Slope (%)	N/A
B Slope (%)	0.9	E Slope (%)	0.8	H Slope (%)	N/A	K Slope (%)	N/A
A Slope (%)	1.3	F Slope (%)	0.1	G Slope (%)	N/A	J Slope (%)	N/A
N/A	Parking Space/Access Aisle XSlopes (%)						
C XSlope (%)	3.8	D XSlope (%)	5.1	I XSlope (%)	N/A	L XSlope (%)	N/A
B XSlope (%)	3.8	E XSlope (%)	4.2	H XSlope (%)	N/A	K XSlope (%)	N/A
A XSlope (%)	2.7	F XSlope (%)	2.9	G XSlope (%)	N/A	J XSlope (%)	N/A
