Access Compliance Report

Public Rights-of-Way

(Accessible Street Parking)

Intersection ID: 10034711	Main Street: POINDEXTER_DR	Location: N/A
ADA ID: 0C891BCC105C	ParkingType: ParaPark	Overall Compliance: No
		Severity Score: 0.0
Codes/Mitigation Info/Possible Solution		Field Measurements/Component Compliance

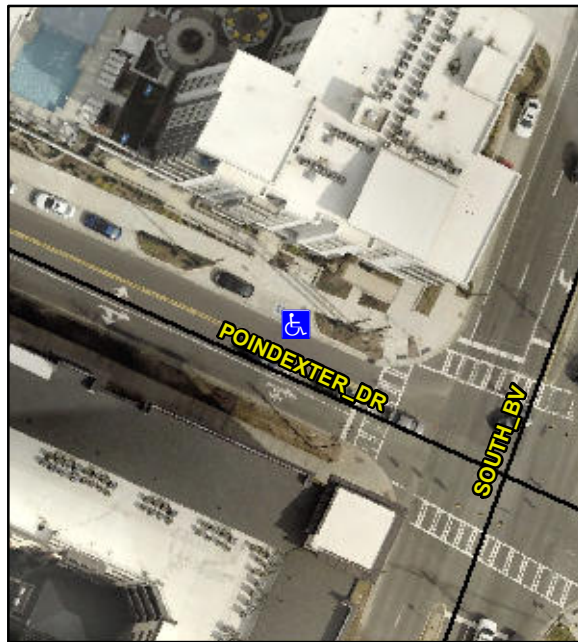
Compliance	Description	Data	Compliance	Description	Data
N/A	Parking Spot At End of Block?	Yes	No	Accessible Route?	No
Yes	Adjacent Sidewalk Width (in)	108.0	No	Access Aisle Marking?	No
Yes	Adjacent Sidewalk Slope (%)	1.2	N/A	Access Aisle Width (in)	N/A
Yes	Adjacent Sidewalk XSlope (%)	0.2	N/A	Access Aisle Length (in)	N/A
Yes	Adjacent Sidewalk Clear of Obstr.	Yes	N/A	Access Aisle Location	N/A
	N/A	Parking Spot Width (in)		77.5	
	N/A	Parking Spot Length (in)		242.5	
	N/A	Van Accessible?		N/A	
	No	Curb Ramp?		No	
	N/A	Identification Sign?		N/A	
	N/A	Sign Height (in)		N/A	
	N/A	Vertical Clearance		N/A	
	N/A	Parking Meter?		N/A	
	N/A	Parking Meter Height (in)		N/A	
	N/A	Meter Operable Parts?		N/A	
	N/A	Meter Clear Space?		N/A	
	N/A	Meter Clear Space Slope (%)		N/A	
	N/A	Meter Clear Space XSlope (%)		N/A	
	N/A	Meter Forward Reach?		N/A	
	N/A	Meter Forward Reach (in)		N/A	
	N/A	Meter Parallel Reach?		N/A	
	N/A	Meter Parallel Reach (in)		N/A

N/A	Parking Space/Access Aisle Slopes (%)						
	C Slope (%)	1.7	D Slope (%)	2.0	I Slope (%)	N/A	L Slope (%)
	B Slope (%)	1.6	E Slope (%)	3.0	H Slope (%)	N/A	K Slope (%)
	A Slope (%)	2.0	F Slope (%)	1.4	G Slope (%)	N/A	J Slope (%)
N/A	Parking Space/Access Aisle XSlopes (%)						
	C XSlope (%)	3.1	D XSlope (%)	3.6	I XSlope (%)	N/A	L XSlope (%)
	B XSlope (%)	2.7	E XSlope (%)	3.2	H XSlope (%)	N/A	K XSlope (%)
	A XSlope (%)	3.0	F XSlope (%)	4.6	G XSlope (%)	N/A	J XSlope (%)

Advise relocating to an area with maximum 2% slopes
