Access Compliance Report

Public Rights-of-Way

(Accessible Street Parking)

Intersection ID: N/A	Main Street: E 5TH ST	Location: N/A
ADA ID: 0CE1E5906CDD	ParkingType: ParaPark	Overall Compliance: No
		Severity Score: 0.0
Codes/Mitigation Info/Possible Solution		Field Measurements/Component Compliance

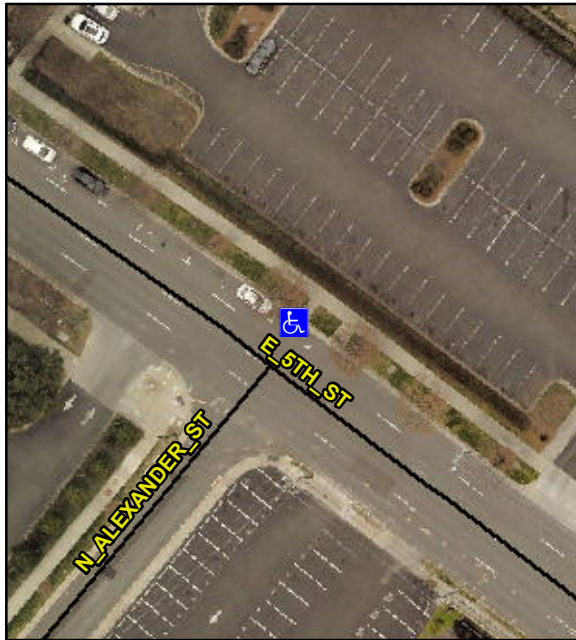
Compliance	Description	Data	Compliance	Description	Data
N/A	Parking Spot At End of Block?	Yes	No	Accessible Route?	No
Yes	Adjacent Sidewalk Width (in)	72.0	No	Access Aisle Marking?	No
Yes	Adjacent Sidewalk Slope (%)	1.4	N/A	Access Aisle Width (in)	N/A
No	Adjacent Sidewalk XSlope (%)	3.3	N/A	Access Aisle Length (in)	N/A
Yes	Adjacent Sidewalk Clear of Obstr.	Yes	N/A	Access Aisle Location	N/A
	N/A	Parking Spot Width (in)		92.0	
	N/A	Parking Spot Length (in)		209.5	
	N/A	Van Accessible?		N/A	
	Yes	Curb Ramp?		Yes	
	N/A	Identification Sign?		N/A	
	N/A	Sign Height (in)		N/A	
	N/A	Vertical Clearance		N/A	
	N/A	Parking Meter?		N/A	
	N/A	Parking Meter Height (in)		N/A	
	N/A	Meter Operable Parts?		N/A	
	N/A	Meter Clear Space?		N/A	
	N/A	Meter Clear Space Slope (%)		N/A	
	N/A	Meter Clear Space XSlope (%)		N/A	
	N/A	Meter Forward Reach?		N/A	
	N/A	Meter Forward Reach (in)		N/A	
	N/A	Meter Parallel Reach?		N/A	
	N/A	Meter Parallel Reach (in)		N/A

N/A	Parking Space/Access Aisle Slopes (%)					
	C Slope (%)	2.3	D Slope (%)	2.0	I Slope (%)	N/A
	B Slope (%)	2.2	E Slope (%)	3.2	H Slope (%)	N/A
	A Slope (%)	2.5	F Slope (%)	2.3	G Slope (%)	N/A
					J Slope (%)	N/A
N/A	Parking Space/Access Aisle XSlopes (%)					
	C XSlope (%)	3.2	D XSlope (%)	4.0	I XSlope (%)	N/A
	B XSlope (%)	2.0	E XSlope (%)	1.0	H XSlope (%)	N/A
	A XSlope (%)	3.0	F XSlope (%)	4.0	G XSlope (%)	N/A
					J XSlope (%)	N/A

Advise relocating to an area with maximum 2% slopes
