# Access Compliance Report

## Public Rights-of-Way

### (Accessible Street Parking)

Intersection ID: N/A	Main Street: OLD PINEVILLE RD	Location: N/A
ADA ID: 17861F20B106	ParkingType: ParaPark	Overall Compliance: No
		Severity Score: 0.0
Codes/Mitigation Info/Possible Solution		Field Measurements/Component Compliance

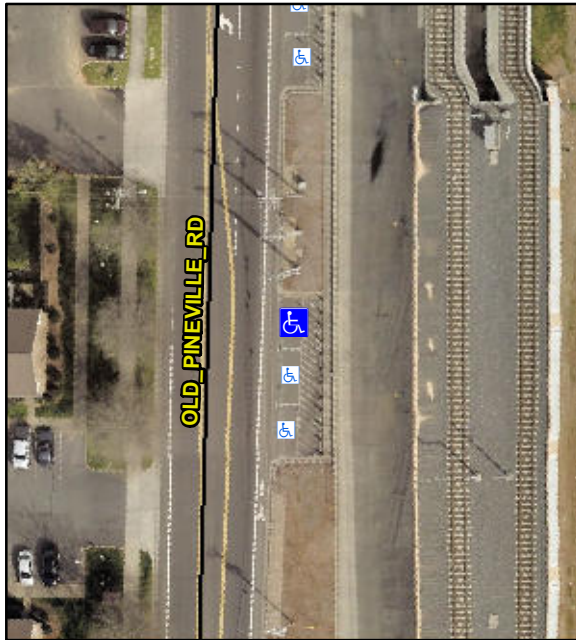
Compliance	Description	Data	Compliance	Description	Data
N/A	Parking Spot At End of Block?	No	Yes	Accessible Route?	Yes
Yes	Adjacent Sidewalk Width (in)	48.0	No	Access Aisle Marking?	Yes
No	Adjacent Sidewalk Slope (%)	2.2	Yes	Access Aisle Width (in)	79.0
Yes	Adjacent Sidewalk XSlope (%)	1.3	No	Access Aisle Length (in)	237.0
Yes	Adjacent Sidewalk Clear of Obstr.	Yes	N/A	Access Aisle Location	Side
	N/A	Parking Spot Width (in)		104.0	
	N/A	Parking Spot Length (in)		237.0	
	N/A	Van Accessible?		N/A	
	No	Curb Ramp?		No	
	N/A	Identification Sign?		N/A	
	N/A	Sign Height (in)		N/A	
	N/A	Vertical Clearance		N/A	
	N/A	Parking Meter?		N/A	
	N/A	Parking Meter Height (in)		N/A	
	N/A	Meter Operable Parts?		N/A	
	N/A	Meter Clear Space?		N/A	
	N/A	Meter Clear Space Slope (%)		N/A	
	N/A	Meter Clear Space XSlope (%)		N/A	
	N/A	Meter Forward Reach?		N/A	
	N/A	Meter Forward Reach (in)		N/A	
	N/A	Meter Parallel Reach?		N/A	
	N/A	Meter Parallel Reach (in)		N/A

N/A	Parking Space/Access Aisle Slopes (%)							
C Slope (%)	1.3	D Slope (%)	3.7	I Slope (%)	N/A	L Slope (%)	N/A	
B Slope (%)	2.3	E Slope (%)	2.9	H Slope (%)	N/A	K Slope (%)	N/A	
A Slope (%)	1.6	F Slope (%)	2.8	G Slope (%)	N/A	J Slope (%)	N/A	
N/A	Parking Space/Access Aisle XSlopes (%)							
C XSlope (%)	1.0	D XSlope (%)	1.9	I XSlope (%)	N/A	L XSlope (%)	N/A	
B XSlope (%)	1.8	E XSlope (%)	2.5	H XSlope (%)	N/A	K XSlope (%)	N/A	
A XSlope (%)	1.7	F XSlope (%)	2.2	G XSlope (%)	N/A	J XSlope (%)	N/A

**Advise relocating to an area with maximum 2% slopes**
