# Access Compliance Report

## Public Rights-of-Way

### (Accessible Street Parking)

Intersection ID: N/A	Main Street: DUCKWORTH AV	Location: N/A
ADA ID: 363C1BCD3EF2	ParkingType: ParaPark	Overall Compliance: No
		Severity Score: 0.0
Codes/Mitigation Info/Possible Solution		Field Measurements/Component Compliance

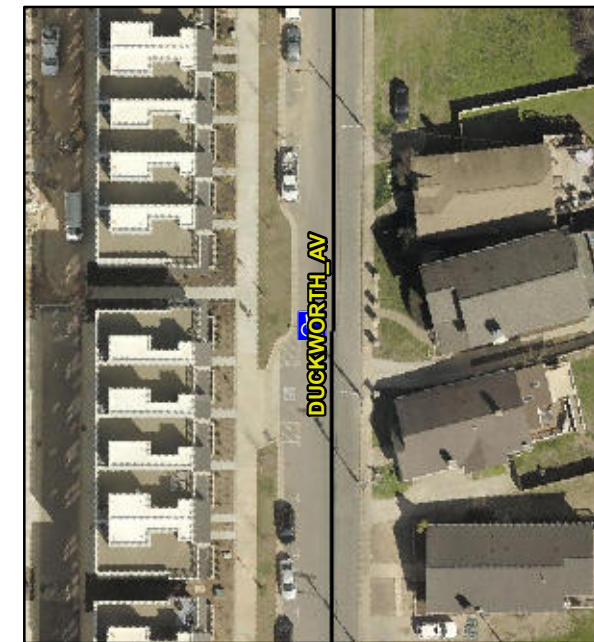
Compliance	Description	Data	Compliance	Description	Data
N/A	Parking Spot At End of Block?	No	Yes	Accessible Route?	Yes
Yes	Adjacent Sidewalk Width (in)	130.0	No	Access Aisle Marking?	Yes
No	Adjacent Sidewalk Slope (%)	2.8	Yes	Access Aisle Width (in)	90.0
Yes	Adjacent Sidewalk XSlope (%)	0.9	No	Access Aisle Length (in)	91.0
Yes	Adjacent Sidewalk Clear of Obstr.	Yes	N/A	Access Aisle Location	Front
	N/A	Parking Spot Width (in)		97.0	
	N/A	Parking Spot Length (in)		261.0	
	N/A	Van Accessible?		N/A	
	Yes	Curb Ramp?		Yes	
	N/A	Identification Sign?		N/A	
	N/A	Sign Height (in)		N/A	
	N/A	Vertical Clearance		N/A	
	N/A	Parking Meter?		N/A	
	N/A	Parking Meter Height (in)		N/A	
	N/A	Meter Operable Parts?		N/A	
	N/A	Meter Clear Space?		N/A	
	N/A	Meter Clear Space Slope (%)		N/A	
	N/A	Meter Clear Space XSlope (%)		N/A	
	N/A	Meter Forward Reach?		N/A	
	N/A	Meter Forward Reach (in)		N/A	
	N/A	Meter Parallel Reach?		N/A	
	N/A	Meter Parallel Reach (in)		N/A

**Advise relocating to an area with maximum 2% slopes**
