Access Compliance Report

Public Rights-of-Way

(Accessible Street Parking)

Intersection ID: N/A	Main Street: OLD PINEVILLE RD	Location: N/A
ADA ID: 64DF751DD352	ParkingType: ParaPark	Overall Compliance: No
		Severity Score: 0.0
Codes/Mitigation Info/Possible Solution		Field Measurements/Component Compliance

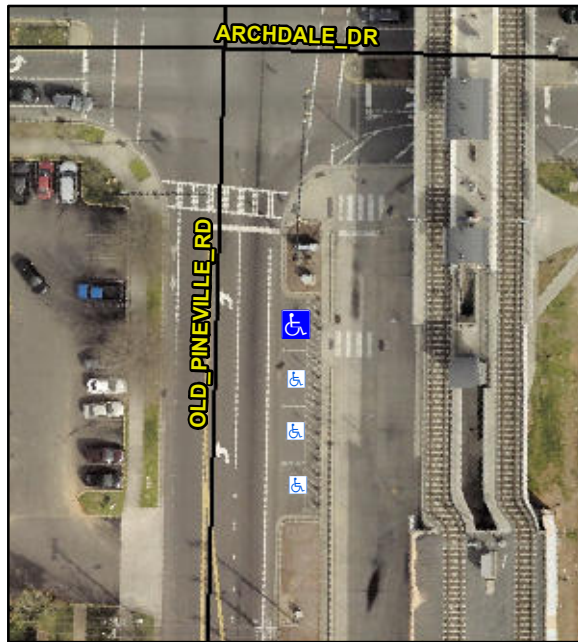
Compliance	Description	Data	Compliance	Description	Data
N/A	Parking Spot At End of Block?	N/A	Yes	Accessible Route?	Yes
Yes	Adjacent Sidewalk Width (in)	60.0	No	Access Aisle Marking?	Yes
Yes	Adjacent Sidewalk Slope (%)	2.2	No	Access Aisle Width (in)	49.0
No	Adjacent Sidewalk XSlope (%)	5.8	Yes	Access Aisle Length (in)	242.0
Yes	Adjacent Sidewalk Clear of Obstr.	Yes	N/A	Access Aisle Location	Side
	N/A	Parking Spot Width (in)		104.0	
	N/A	Parking Spot Length (in)		242.0	
	N/A	Van Accessible?		N/A	
	Yes	Curb Ramp?		Yes	
	N/A	Identification Sign?		N/A	
	N/A	Sign Height (in)		N/A	
	N/A	Vertical Clearance		N/A	
	N/A	Parking Meter?		N/A	
	N/A	Parking Meter Height (in)		N/A	
	N/A	Meter Operable Parts?		N/A	
	N/A	Meter Clear Space?		N/A	
	N/A	Meter Clear Space Slope (%)		N/A	
	N/A	Meter Clear Space XSlope (%)		N/A	
	N/A	Meter Forward Reach?		N/A	
	N/A	Meter Forward Reach (in)		N/A	
	N/A	Meter Parallel Reach?		N/A	
	N/A	Meter Parallel Reach (in)		N/A

Advise relocating to an area with maximum 2% slopes
