Access Compliance Report

Public Rights-of-Way

(Accessible Street Parking)

Intersection ID: 13019	Main Street: E_STONEWALL_ST	Location:	N/A
ADA ID: 7454D5CE4783	ParkingType: ParaPark	Overall Compliance: No	Severity Score: 0.0
Codes/Mitigation Info/Possible Solution		Field Measurements/Component Compliance

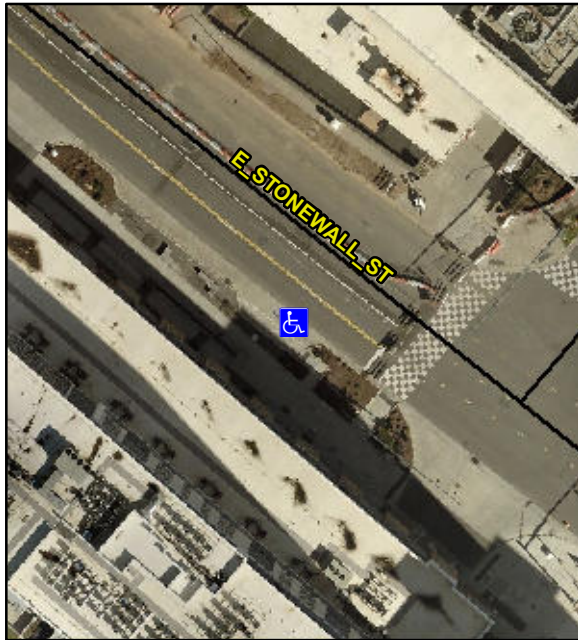
Compliance	Description	Data	Compliance	Description	Data
N/A	Parking Spot At End of Block?	Yes	Yes	Accessible Route?	Yes
Yes	Adjacent Sidewalk Width (in)	100.0	No	Access Aisle Marking?	Yes
Yes	Adjacent Sidewalk Slope (%)	0.9	No	Access Aisle Width (in)	39.0
Yes	Adjacent Sidewalk XSlope (%)	1.9	No	Access Aisle Length (in)	289.0
Yes	Adjacent Sidewalk Clear of Obstr.	Yes	N/A	Access Aisle Location	Side
	N/A	Parking Spot Width (in)		88.0	
	N/A	Parking Spot Length (in)		289.5	
	N/A	Van Accessible?		N/A	
	Yes	Curb Ramp?		Yes	
	N/A	Identification Sign?		N/A	
	N/A	Sign Height (in)		N/A	
	N/A	Vertical Clearance		N/A	
	N/A	Parking Meter?		N/A	
	N/A	Parking Meter Height (in)		N/A	
	N/A	Meter Operable Parts?		N/A	
	N/A	Meter Clear Space?		N/A	
	N/A	Meter Clear Space Slope (%)		N/A	
	N/A	Meter Clear Space XSlope (%)		N/A	
	N/A	Meter Forward Reach?		N/A	
	N/A	Meter Forward Reach (in)		N/A	
	N/A	Meter Parallel Reach?		N/A	
	N/A	Meter Parallel Reach (in)		N/A

N/A	Parking Space/Access Aisle Slopes (%)							
	C Slope (%)	2.2	D Slope (%)	1.4	I Slope (%)	N/A	L Slope (%)	N/A
	B Slope (%)	1.0	E Slope (%)	1.4	H Slope (%)	N/A	K Slope (%)	N/A
	A Slope (%)	0.8	F Slope (%)	0.4	G Slope (%)	N/A	J Slope (%)	N/A
N/A	Parking Space/Access Aisle XSlopes (%)							
	C XSlope (%)	1.8	D XSlope (%)	1.1	I XSlope (%)	N/A	L XSlope (%)	N/A
	B XSlope (%)	2.0	E XSlope (%)	1.1	H XSlope (%)	N/A	K XSlope (%)	N/A
	A XSlope (%)	0.5	F XSlope (%)	0.7	G XSlope (%)	N/A	J XSlope (%)	N/A

Advise relocating to an area with maximum 2% slopes
