# Access Compliance Report

## Public Rights-of-Way

### (Accessible Street Parking)

Intersection ID: N/A	Main Street: GREENWOOD CLIFF RD	Location: N/A
ADA ID: 77BEB04FA26D	ParkingType: ParaPark	Overall Compliance: No
		Severity Score: 0.0
Codes/Mitigation Info/Possible Solution		Field Measurements/Component Compliance

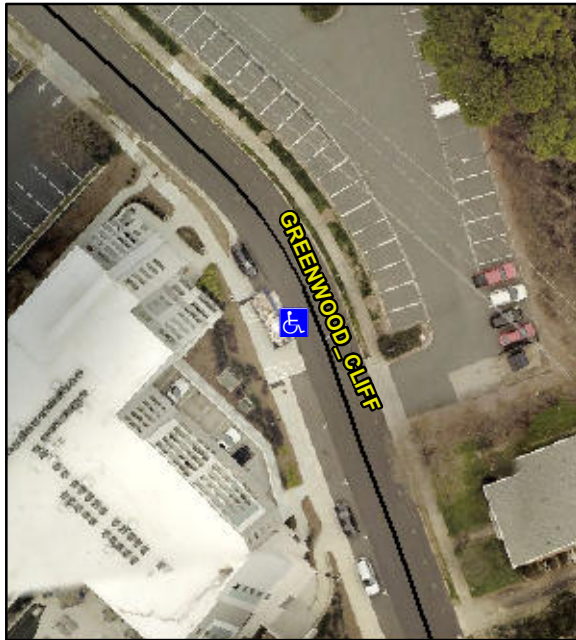
Compliance	Description	Data	Compliance	Description	Data
N/A	Parking Spot At End of Block?	No	Yes	Accessible Route?	Yes
Yes	Adjacent Sidewalk Width (in)	74.0	No	Access Aisle Marking?	Yes
Yes	Adjacent Sidewalk Slope (%)	0.5	Yes	Access Aisle Width (in)	60
No	Adjacent Sidewalk XSlope (%)	3.0	No	Access Aisle Length (in)	229
N/A	Adjacent Sidewalk Clear of Obstr.	N/A	N/A	Access Aisle Location	Front
	N/A	Parking Spot Width (in)		91.0	
	N/A	Parking Spot Length (in)		229.0	
	N/A	Van Accessible?		N/A	
	Yes	Curb Ramp?		Yes	
	N/A	Identification Sign?		N/A	
	N/A	Sign Height (in)		N/A	
	N/A	Vertical Clearance		N/A	
	N/A	Parking Meter?		N/A	
	N/A	Parking Meter Height (in)		N/A	
	N/A	Meter Operable Parts?		N/A	
	N/A	Meter Clear Space?		N/A	
	N/A	Meter Clear Space Slope (%)		N/A	
	N/A	Meter Clear Space XSlope (%)		N/A	
	N/A	Meter Forward Reach?		N/A	
	N/A	Meter Forward Reach (in)		N/A	
	N/A	Meter Parallel Reach?		N/A	
	N/A	Meter Parallel Reach (in)		N/A

N/A	Parking Space/Access Aisle Slopes (%)							
	C Slope (%)	2.2	D Slope (%)	0.8	I Slope (%)	N/A	L Slope (%)	N/A
	B Slope (%)	1.8	E Slope (%)	0.0	H Slope (%)	N/A	K Slope (%)	N/A
	A Slope (%)	0.4	F Slope (%)	1.2	G Slope (%)	N/A	J Slope (%)	N/A
N/A	Parking Space/Access Aisle XSlopes (%)							
	C XSlope (%)	2.1	D XSlope (%)	2.4	I XSlope (%)	N/A	L XSlope (%)	N/A
	B XSlope (%)	5.3	E XSlope (%)	5.2	H XSlope (%)	N/A	K XSlope (%)	N/A
	A XSlope (%)	4.5	F XSlope (%)	3.9	G XSlope (%)	N/A	J XSlope (%)	N/A

**Advise relocating to an area with maximum 2% slopes**
