# Access Compliance Report

## Public Rights-of-Way

### (Accessible Street Parking)

Intersection ID: N/A	Main Street: OLD PINEVILLE RD	Location: N/A
ADA ID: 7BFB0ECBE720	ParkingType: ParaPark	Overall Compliance: No
		Severity Score: 0.0
Codes/Mitigation Info/Possible Solution		Field Measurements/Component Compliance

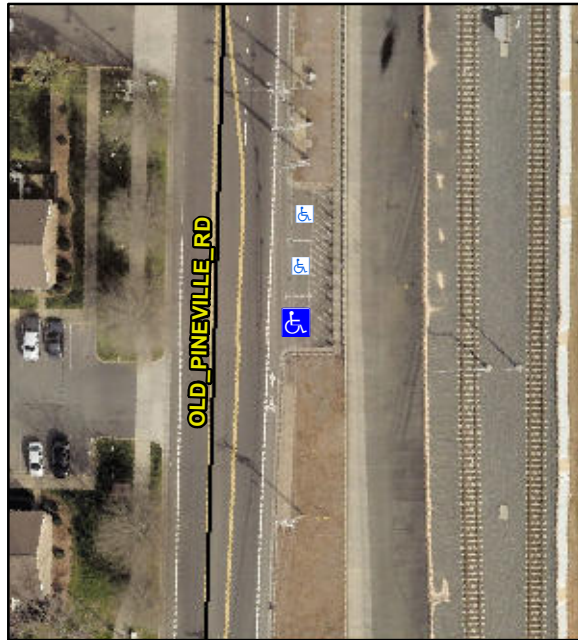
Compliance	Description	Data	Compliance	Description	Data
N/A	Parking Spot At End of Block?	No	Yes	Accessible Route?	Yes
Yes	Adjacent Sidewalk Width (in)	48.0	No	Access Aisle Marking?	Yes
No	Adjacent Sidewalk Slope (%)	2.2	Yes	Access Aisle Width (in)	101.0
Yes	Adjacent Sidewalk XSlope (%)	0.6	No	Access Aisle Length (in)	236.0
Yes	Adjacent Sidewalk Clear of Obstr.	Yes	N/A	Access Aisle Location	Side
	N/A	Parking Spot Width (in)		103.0	
	N/A	Parking Spot Length (in)		236.0	
	N/A	Van Accessible?		N/A	
	No	Curb Ramp?		No	
	N/A	Identification Sign?		N/A	
	N/A	Sign Height (in)		N/A	
	N/A	Vertical Clearance		N/A	
	N/A	Parking Meter?		N/A	
	N/A	Parking Meter Height (in)		N/A	
	N/A	Meter Operable Parts?		N/A	
	N/A	Meter Clear Space?		N/A	
	N/A	Meter Clear Space Slope (%)		N/A	
	N/A	Meter Clear Space XSlope (%)		N/A	
	N/A	Meter Forward Reach?		N/A	
	N/A	Meter Forward Reach (in)		N/A	
	N/A	Meter Parallel Reach?		N/A	
	N/A	Meter Parallel Reach (in)		N/A

**Advise relocating to an area with maximum 2% slopes**
