Access Compliance Report Public Rights-of-Way (Accessible Street Parking)

Intersection ID: 10031761	Main Street: MIDWAY_PARK_DR	Location: N/A
ADA ID: A0DA847BA7BF	ParkingType: ParaPark	Overall Compliance: No
Codes/Mitigation Info/Possible Solution		Severity Score: 0.0
		Field Measurements/Component Compliance

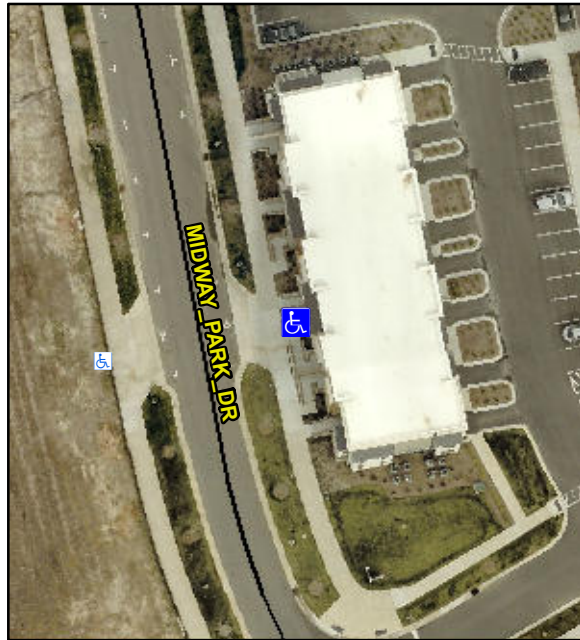
Compliance	Description	Data	Compliance	Description	Data
N/A	Parking Spot At End of Block?	Yes	Yes	Accessible Route?	Yes
Yes	Adjacent Sidewalk Width (in)	124.0	No	Access Aisle Marking?	No
Yes	Adjacent Sidewalk Slope (%)	1.6	N/A	Access Aisle Width (in)	70.0
Yes	Adjacent Sidewalk XSlope (%)	1.1	N/A	Access Aisle Length (in)	296.0
Yes	Adjacent Sidewalk Clear of Obstr.	Yes	N/A	Access Aisle Location	Side
	N/A	Parking Spot Width (in)		80.5	
	N/A	Parking Spot Length (in)		391.0	
	N/A	Van Accessible?		N/A	
	Yes	Curb Ramp?		Yes	
	N/A	Identification Sign?		N/A	
	N/A	Sign Height (in)		N/A	
	N/A	Vertical Clearance		N/A	
	N/A	Parking Meter?		N/A	
	N/A	Parking Meter Height (in)		N/A	
	N/A	Meter Operable Parts?		N/A	
	N/A	Meter Clear Space?		N/A	
	N/A	Meter Clear Space Slope (%)		N/A	
	N/A	Meter Clear Space XSlope (%)		N/A	
	N/A	Meter Forward Reach?		N/A	
	N/A	Meter Forward Reach (in)		N/A	
	N/A	Meter Parallel Reach?		N/A	
	N/A	Meter Parallel Reach (in)		N/A

Advise relocating to an area with maximum 2% slopes
