Access Compliance Report

Public Rights-of-Way

(Accessible Street Parking)

Intersection ID: 10033477	Main Street: OLD_PINEVILLE_RD	Location: N/A
ADA ID: A748C96C4496	ParkingType: ParaPark	Overall Compliance: No
		Severity Score: 0.0
Codes/Mitigation Info/Possible Solution		Field Measurements/Component Compliance

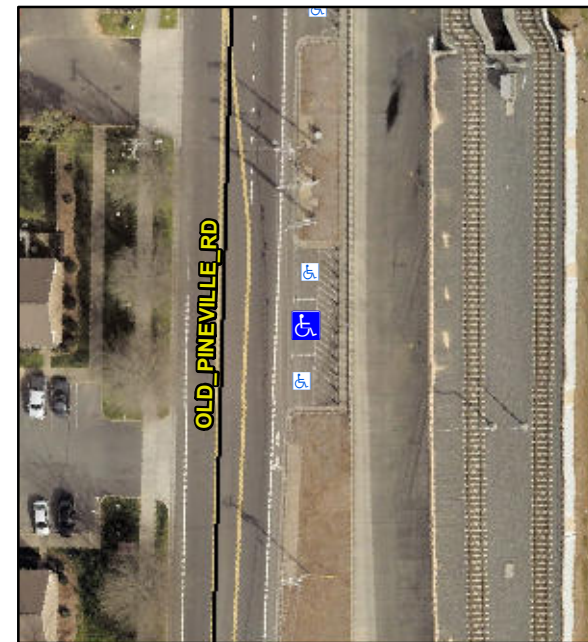
Compliance	Description	Data	Compliance	Description	Data
N/A	Parking Spot At End of Block?	No	Yes	Accessible Route?	Yes
Yes	Adjacent Sidewalk Width (in)	48.0	N/A	Access Aisle Marking?	Yes
Yes	Adjacent Sidewalk Slope (%)	1.6	Yes	Access Aisle Width (in)	91.0
Yes	Adjacent Sidewalk XSlope (%)	0.8	Yes	Access Aisle Length (in)	256.0
N/A	Adjacent Sidewalk Clear of Obstr.	N/A	N/A	Access Aisle Location	Side
	N/A	Parking Spot Width (in)		104.0	
	N/A	Parking Spot Length (in)		256.0	
	N/A	Van Accessible?		N/A	
	No	Curb Ramp?		No	
	N/A	Identification Sign?		N/A	
	N/A	Sign Height (in)		N/A	
	N/A	Vertical Clearance		N/A	
	N/A	Parking Meter?		N/A	
	N/A	Parking Meter Height (in)		N/A	
	N/A	Meter Operable Parts?		N/A	
	N/A	Meter Clear Space?		N/A	
	N/A	Meter Clear Space Slope (%)		N/A	
	N/A	Meter Clear Space XSlope (%)		N/A	
	N/A	Meter Forward Reach?		N/A	
	N/A	Meter Forward Reach (in)		N/A	
	N/A	Meter Parallel Reach?		N/A	
	N/A	Meter Parallel Reach (in)		N/A

Advise relocating to an area with maximum 2% slopes
