Access Compliance Report

Public Rights-of-Way

(Accessible Street Parking)

Intersection ID: 10035679	Main Street: RED_RUST_LN	Location: N/A
ADA ID: ACC9764C9D0C	ParkingType: ParaPark	Overall Compliance: No
		Severity Score: 0.0
Codes/Mitigation Info/Possible Solution		Field Measurements/Component Compliance

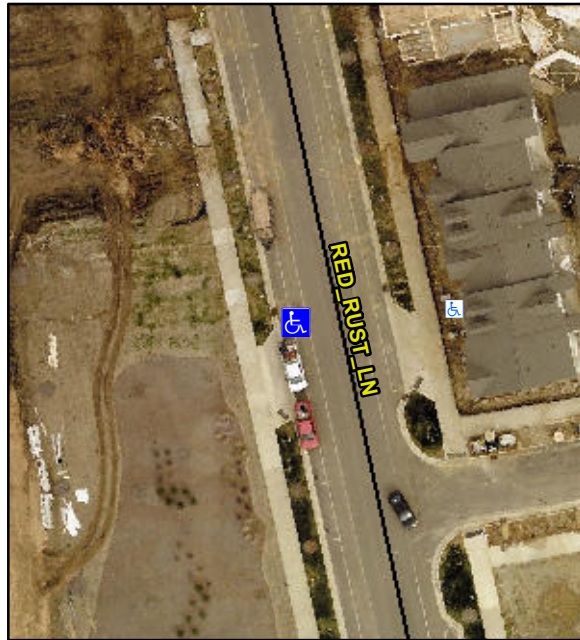
Compliance	Description	Data	Compliance	Description	Data
N/A	Parking Spot At End of Block?	No	Yes	Accessible Route?	Yes
Yes	Adjacent Sidewalk Width (in)	128.0	No	Access Aisle Marking?	No
Yes	Adjacent Sidewalk Slope (%)	1.1	N/A	Access Aisle Width (in)	62.0
Yes	Adjacent Sidewalk XSlope (%)	1.6	N/A	Access Aisle Length (in)	276.0
Yes	Adjacent Sidewalk Clear of Obstr.	Yes	N/A	Access Aisle Location	Side
	N/A	Parking Spot Width (in)		83.0	
	N/A	Parking Spot Length (in)		524.0	
	N/A	Van Accessible?		N/A	
	Yes	Curb Ramp?		Yes	
	N/A	Identification Sign?		N/A	
	N/A	Sign Height (in)		N/A	
	N/A	Vertical Clearance		N/A	
	N/A	Parking Meter?		N/A	
	N/A	Parking Meter Height (in)		N/A	
	N/A	Meter Operable Parts?		N/A	
	N/A	Meter Clear Space?		N/A	
	N/A	Meter Clear Space Slope (%)		N/A	
	N/A	Meter Clear Space XSlope (%)		N/A	
	N/A	Meter Forward Reach?		N/A	
	N/A	Meter Forward Reach (in)		N/A	
	N/A	Meter Parallel Reach?		N/A	
	N/A	Meter Parallel Reach (in)		N/A

N/A	Parking Space/Access Aisle Slopes (%)					
	C Slope (%)	2.3	D Slope (%)	1.1	I Slope (%)	N/A
	B Slope (%)	2.6	E Slope (%)	2.1	H Slope (%)	N/A
	A Slope (%)	3.4	F Slope (%)	4.7	G Slope (%)	N/A
					J Slope (%)	N/A
N/A	Parking Space/Access Aisle XSlopes (%)					
	C XSlope (%)	4.7	D XSlope (%)	1.6	I XSlope (%)	N/A
	B XSlope (%)	4.1	E XSlope (%)	0.9	H XSlope (%)	N/A
	A XSlope (%)	3.2	F XSlope (%)	3.3	G XSlope (%)	N/A
					J XSlope (%)	N/A

Advise relocating to an area with maximum 2% slopes
