# Access Compliance Report

## Public Rights-of-Way

### (Accessible Street Parking)

Intersection ID: 10031919	Main Street: MOCKINGBIRD_LN	Location:	N/A
ADA ID: BDDFC852A5A1	ParkingType: ParaPark	Overall Compliance: No	Severity Score: 0.0
Codes/Mitigation Info/Possible Solution		Field Measurements/Component Compliance

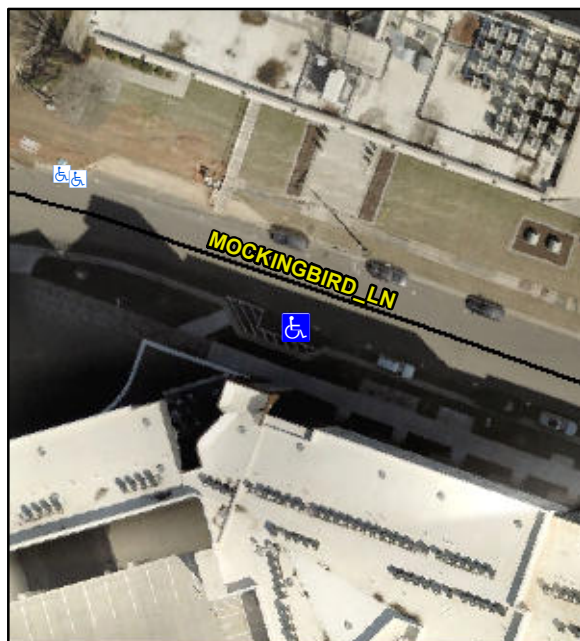
Compliance	Description	Data	Compliance	Description	Data
N/A	Parking Spot At End of Block?	No	Yes	Accessible Route?	Yes
Yes	Adjacent Sidewalk Width (in)	94.0	No	Access Aisle Marking?	Yes
Yes	Adjacent Sidewalk Slope (%)	1.3	No	Access Aisle Width (in)	57.0
Yes	Adjacent Sidewalk XSlope (%)	1.2	Yes	Access Aisle Length (in)	260.0
Yes	Adjacent Sidewalk Clear of Obstr.	Yes	N/A	Access Aisle Location	Side
	N/A	Parking Spot Width (in)		87.0	
	N/A	Parking Spot Length (in)		260.0	
	N/A	Van Accessible?		N/A	
	Yes	Curb Ramp?		Yes	
	N/A	Identification Sign?		N/A	
	N/A	Sign Height (in)		N/A	
	N/A	Vertical Clearance		N/A	
	N/A	Parking Meter?		N/A	
	N/A	Parking Meter Height (in)		N/A	
	N/A	Meter Operable Parts?		N/A	
	N/A	Meter Clear Space?		N/A	
	N/A	Meter Clear Space Slope (%)		N/A	
	N/A	Meter Clear Space XSlope (%)		N/A	
	N/A	Meter Forward Reach?		N/A	
	N/A	Meter Forward Reach (in)		N/A	
	N/A	Meter Parallel Reach?		N/A	
	N/A	Meter Parallel Reach (in)		N/A

**Advise relocating to an area with maximum 2% slopes**

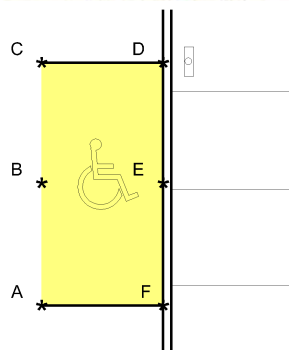
N/A	Parking Space/Access Aisle Slopes (%)							
	C Slope (%)	0.5	D Slope (%)	2.1	I Slope (%)	N/A	L Slope (%)	N/A
	B Slope (%)	1.4	E Slope (%)	1.0	H Slope (%)	N/A	K Slope (%)	N/A
	A Slope (%)	1.4	F Slope (%)	0.8	G Slope (%)	N/A	J Slope (%)	N/A
N/A	Parking Space/Access Aisle XSlopes (%)							
	C XSlope (%)	4.1	D XSlope (%)	0.0	I XSlope (%)	N/A	L XSlope (%)	N/A
	B XSlope (%)	1.3	E XSlope (%)	0.8	H XSlope (%)	N/A	K XSlope (%)	N/A
	A XSlope (%)	1.2	F XSlope (%)	0.2	G XSlope (%)	N/A	J XSlope (%)	N/A
