Access Compliance Report

Public Rights-of-Way

(Accessible Street Parking)

Intersection ID: N/A	Main Street: Fairwood Ave	Location: N/A
ADA ID: C042487B0F8D	ParkingType: ParaPark	Overall Compliance: No
		Severity Score: 0.0
Codes/Mitigation Info/Possible Solution		Field Measurements/Component Compliance

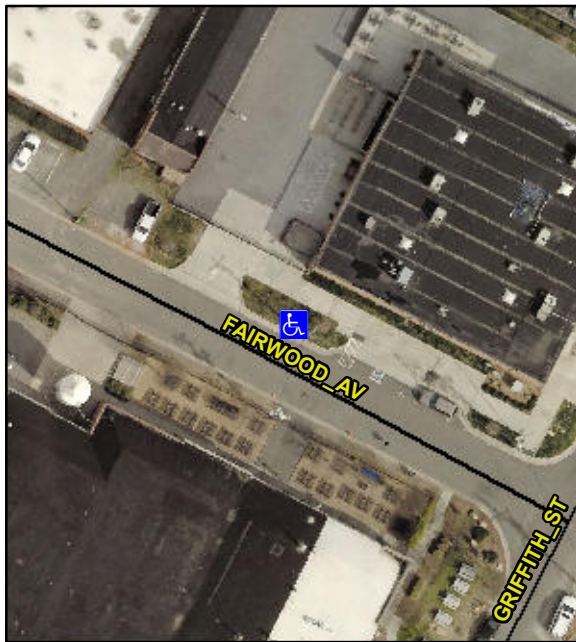
Compliance	Description	Data	Compliance	Description	Data
N/A	Parking Spot At End of Block?	No	Yes	Accessible Route?	Yes
Yes	Adjacent Sidewalk Width (in)	127.0	N/A	Access Aisle Marking?	Yes
Yes	Adjacent Sidewalk Slope (%)	0.3	Yes	Access Aisle Width (in)	60
Yes	Adjacent Sidewalk XSlope (%)	1.3	Yes	Access Aisle Length (in)	264
Yes	Adjacent Sidewalk Clear of Obstr.	Yes	N/A	Access Aisle Location	Front
	N/A	Parking Spot Width (in)		119	
	N/A	Parking Spot Length (in)		264.0	
	N/A	Van Accessible?		N/A	
	Yes	Curb Ramp?		Yes	
	N/A	Identification Sign?		N/A	
	N/A	Sign Height (in)		N/A	
	N/A	Vertical Clearance		N/A	
	N/A	Parking Meter?		N/A	
	N/A	Parking Meter Height (in)		N/A	
	N/A	Meter Operable Parts?		N/A	
	N/A	Meter Clear Space?		N/A	
	N/A	Meter Clear Space Slope (%)		N/A	
	N/A	Meter Clear Space XSlope (%)		N/A	
	N/A	Meter Forward Reach?		N/A	
	N/A	Meter Forward Reach (in)		N/A	
	N/A	Meter Parallel Reach?		N/A	
	N/A	Meter Parallel Reach (in)		N/A

N/A	Parking Space/Access Aisle Slopes (%)					
C Slope (%)	0.2	D Slope (%)	0.8	I Slope (%)	N/A	L Slope (%)
B Slope (%)	1.3	E Slope (%)	1.3	H Slope (%)	N/A	K Slope (%)
A Slope (%)	0.2	F Slope (%)	0.6	G Slope (%)	N/A	J Slope (%)
N/A	Parking Space/Access Aisle XSlopes (%)					
C XSlope (%)	2.6	D XSlope (%)	0.9	I XSlope (%)	N/A	L XSlope (%)
B XSlope (%)	1.7	E XSlope (%)	2.0	H XSlope (%)	N/A	K XSlope (%)
A XSlope (%)	0.2	F XSlope (%)	1.4	G XSlope (%)	N/A	J XSlope (%)

Advise relocating to an area with maximum 2% slopes
