Access Compliance Report

Public Rights-of-Way

(Accessible Street Parking)

Intersection ID: N/A	Main Street: OLD PINEVILLE RD	Location: N/A
ADA ID: C11865A2C4FC	ParkingType: ParaPark	Overall Compliance: No
		Severity Score: 0.0
Codes/Mitigation Info/Possible Solution		Field Measurements/Component Compliance

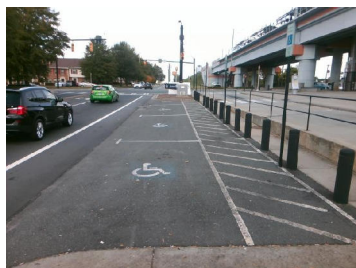
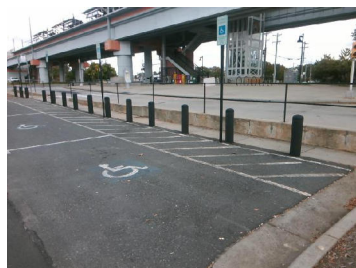
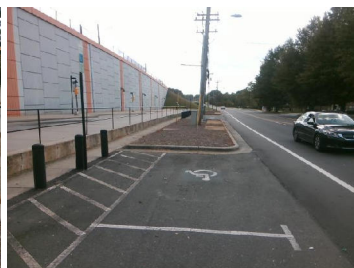
Compliance	Description	Data	Compliance	Description	Data
N/A	Parking Spot At End of Block?	N/A	Yes	Accessible Route?	Yes
Yes	Adjacent Sidewalk Width (in)	48.0	No	Access Aisle Marking?	Yes
No	Adjacent Sidewalk Slope (%)	2.1	No	Access Aisle Width (in)	58.5
Yes	Adjacent Sidewalk XSlope (%)	0.4	Yes	Access Aisle Length (in)	240.0
Yes	Adjacent Sidewalk Clear of Obstr.	Yes	N/A	Access Aisle Location	Side
	N/A	Parking Spot Width (in)		104.0	
	N/A	Parking Spot Length (in)		240.0	
	N/A	Van Accessible?		N/A	
	No	Curb Ramp?		No	
	N/A	Identification Sign?		N/A	
	N/A	Sign Height (in)		N/A	
	N/A	Vertical Clearance		N/A	
	N/A	Parking Meter?		N/A	
	N/A	Parking Meter Height (in)		N/A	
	N/A	Meter Operable Parts?		N/A	
	N/A	Meter Clear Space?		N/A	
	N/A	Meter Clear Space Slope (%)		N/A	
	N/A	Meter Clear Space XSlope (%)		N/A	
	N/A	Meter Forward Reach?		N/A	
	N/A	Meter Forward Reach (in)		N/A	
	N/A	Meter Parallel Reach?		N/A	
	N/A	Meter Parallel Reach (in)		N/A

Advise relocating to an area with maximum 2% slopes
