Access Compliance Report

Public Rights-of-Way

(Accessible Street Parking)

Intersection ID: 10022318	Main Street: CAMDEN_RD	Location: N/A
ADA ID: D94C9C6130FC	ParkingType: ParaPark	Overall Compliance: No
		Severity Score: 0.0
Codes/Mitigation Info/Possible Solution		Field Measurements/Component Compliance

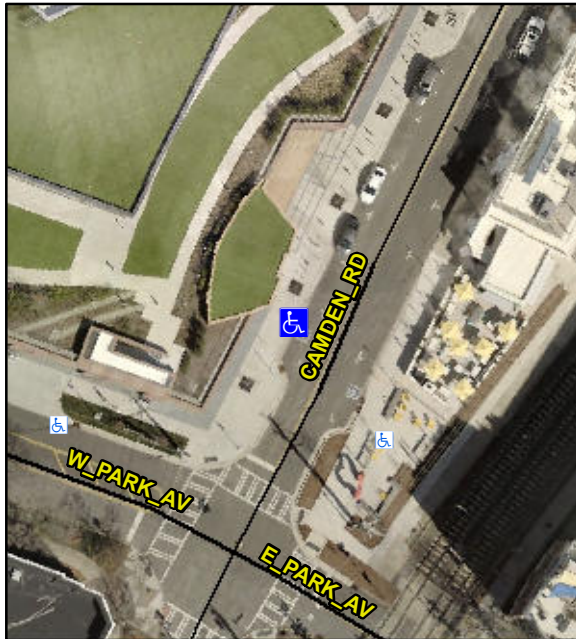
Compliance	Description	Data	Compliance	Description	Data
N/A	Parking Spot At End of Block?	Yes	Yes	Accessible Route?	Yes
Yes	Adjacent Sidewalk Width (in)	73.0	No	Access Aisle Marking?	No
Yes	Adjacent Sidewalk Slope (%)	0.5	N/A	Access Aisle Width (in)	60
No	Adjacent Sidewalk XSlope (%)	2.1	N/A	Access Aisle Length (in)	272
Yes	Adjacent Sidewalk Clear of Obstr.	Yes	N/A	Access Aisle Location	N/A
	N/A	Parking Spot Width (in)		83.0	
	N/A	Parking Spot Length (in)		272.0	
	N/A	Van Accessible?		N/A	
	Yes	Curb Ramp?		Yes	
	N/A	Identification Sign?		N/A	
	N/A	Sign Height (in)		N/A	
	N/A	Vertical Clearance		N/A	
	N/A	Parking Meter?		N/A	
	N/A	Parking Meter Height (in)		N/A	
	N/A	Meter Operable Parts?		N/A	
	N/A	Meter Clear Space?		N/A	
	N/A	Meter Clear Space Slope (%)		N/A	
	N/A	Meter Clear Space XSlope (%)		N/A	
	N/A	Meter Forward Reach?		N/A	
	N/A	Meter Forward Reach (in)		N/A	
	N/A	Meter Parallel Reach?		N/A	
	N/A	Meter Parallel Reach (in)		N/A

Possible Solutions:

Advise relocating to an area with maximum 2% slopes
