Access Compliance Report

Public Rights-of-Way

(Accessible Street Parking)

Intersection ID: N/A	Main Street: ISOM ST	Location: N/A
ADA ID: EF24545ECDB8	ParkingType: ParaPark	Overall Compliance: No
		Severity Score: 0.0
Codes/Mitigation Info/Possible Solution		Field Measurements/Component Compliance

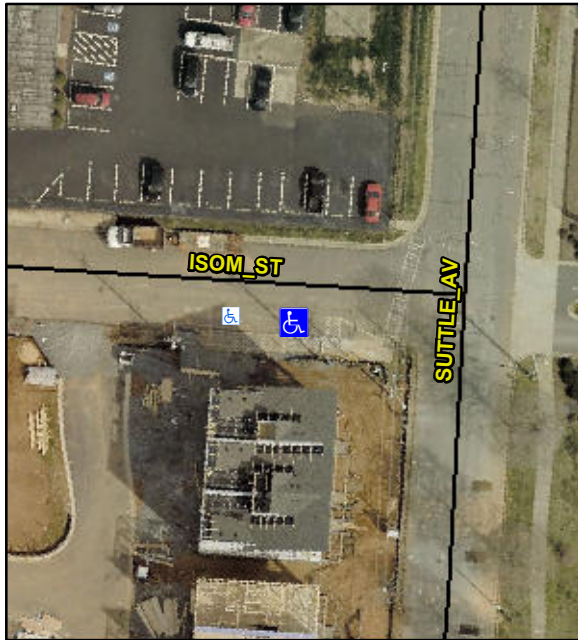
Compliance	Description	Data	Compliance	Description	Data
N/A	Parking Spot At End of Block?	Yes	Yes	Accessible Route?	Yes
No	Adjacent Sidewalk Width (in)	N/A	No	Access Aisle Marking?	Yes
No	Adjacent Sidewalk Slope (%)	N/A	Yes	Access Aisle Width (in)	93.0
No	Adjacent Sidewalk XSlope (%)	N/A	No	Access Aisle Length (in)	342.0
No	Adjacent Sidewalk Clear of Obstr.	No	N/A	Access Aisle Location	Side
	N/A	Parking Spot Width (in)		102.0	
	N/A	Parking Spot Length (in)		269.0	
	N/A	Van Accessible?		N/A	
	No	Curb Ramp?		No	
	N/A	Identification Sign?		N/A	
	N/A	Sign Height (in)		N/A	
	N/A	Vertical Clearance		N/A	
	N/A	Parking Meter?		N/A	
	N/A	Parking Meter Height (in)		N/A	
	N/A	Meter Operable Parts?		N/A	
	N/A	Meter Clear Space?		N/A	
	N/A	Meter Clear Space Slope (%)		N/A	
	N/A	Meter Clear Space XSlope (%)		N/A	
	N/A	Meter Forward Reach?		N/A	
	N/A	Meter Forward Reach (in)		N/A	
	N/A	Meter Parallel Reach?		N/A	
	N/A	Meter Parallel Reach (in)		N/A

N/A	Parking Space/Access Aisle Slopes (%)							
	C Slope (%)	1.8	D Slope (%)	2.1	I Slope (%)	N/A	L Slope (%)	N/A
	B Slope (%)	1.2	E Slope (%)	0.1	H Slope (%)	N/A	K Slope (%)	N/A
	A Slope (%)	1.0	F Slope (%)	1.8	G Slope (%)	N/A	J Slope (%)	N/A
N/A	Parking Space/Access Aisle XSlopes (%)							
	C XSlope (%)	2.3	D XSlope (%)	1.1	I XSlope (%)	N/A	L XSlope (%)	N/A
	B XSlope (%)	0.3	E XSlope (%)	1.9	H XSlope (%)	N/A	K XSlope (%)	N/A
	A XSlope (%)	1.6	F XSlope (%)	2.6	G XSlope (%)	N/A	J XSlope (%)	N/A

Advise relocating to an area with maximum 2% slopes
