# Access Compliance Report

## Public Rights-of-Way

### (Accessible Street Parking)

Intersection ID: N/A	Main Street: SAM'S DR	Location: N/A
ADA ID: EF96E129297C	ParkingType: ParaPark	Overall Compliance: No
		Severity Score: 0.0
Codes/Mitigation Info/Possible Solution		Field Measurements/Component Compliance

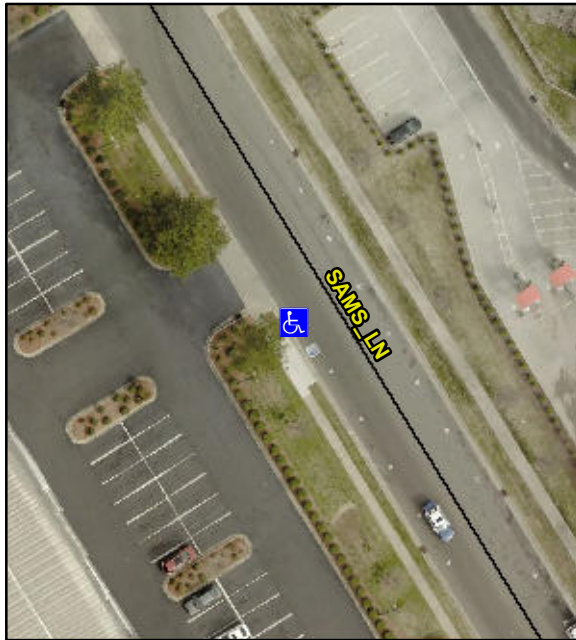
Compliance	Description	Data	Compliance	Description	Data
N/A	Parking Spot At End of Block?	Yes	No	Accessible Route?	No
Yes	Adjacent Sidewalk Width (in)	98.0	No	Access Aisle Marking?	No
Yes	Adjacent Sidewalk Slope (%)	3.4	N/A	Access Aisle Width (in)	N/A
Yes	Adjacent Sidewalk XSlope (%)	1.5	N/A	Access Aisle Length (in)	N/A
Yes	Adjacent Sidewalk Clear of Obstr.	Yes	N/A	Access Aisle Location	N/A
	N/A	Parking Spot Width (in)		71.0	
	N/A	Parking Spot Length (in)		260.0	
	N/A	Van Accessible?		N/A	
	No	Curb Ramp?		No	
	N/A	Identification Sign?		N/A	
	N/A	Sign Height (in)		N/A	
	N/A	Vertical Clearance		N/A	
	N/A	Parking Meter?		N/A	
	N/A	Parking Meter Height (in)		N/A	
	N/A	Meter Operable Parts?		N/A	
	N/A	Meter Clear Space?		N/A	
	N/A	Meter Clear Space Slope (%)		N/A	
	N/A	Meter Clear Space XSlope (%)		N/A	
	N/A	Meter Forward Reach?		N/A	
	N/A	Meter Forward Reach (in)		N/A	
	N/A	Meter Parallel Reach?		N/A	
	N/A	Meter Parallel Reach (in)		N/A

**Advise relocating to an area with maximum 2% slopes**
