Access Compliance Report

Public Rights-of-Way

(Accessible Street Parking)

Intersection ID: N/A	Main Street: POTOMAC RIVER PY	Location: N/A
ADA ID: F04DDFABD8E1	ParkingType: ParaPark	Overall Compliance: No
		Severity Score: 0.0
Codes/Mitigation Info/Possible Solution		Field Measurements/Component Compliance

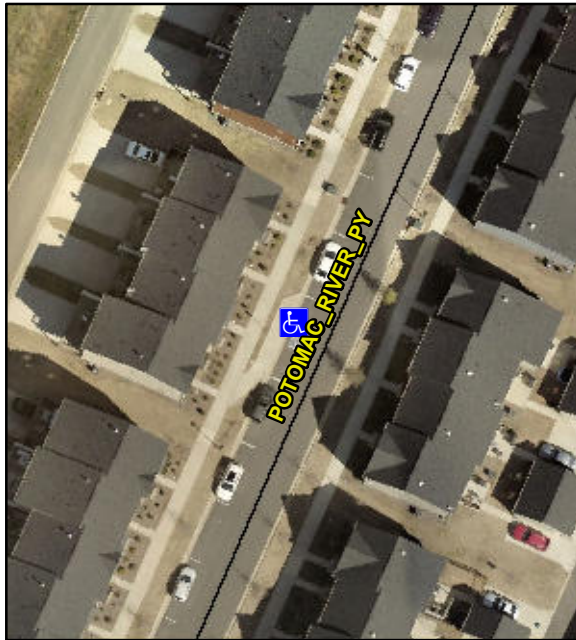
Compliance	Description	Data	Compliance	Description	Data
N/A	Parking Spot At End of Block?	N/A	Yes	Accessible Route?	Yes
Yes	Adjacent Sidewalk Width (in)	72.0	No	Access Aisle Marking?	No
No	Adjacent Sidewalk Slope (%)	2.9	N/A	Access Aisle Width (in)	56.5
Yes	Adjacent Sidewalk XSlope (%)	1.3	N/A	Access Aisle Length (in)	301.0
N/A	Adjacent Sidewalk Clear of Obstr.	N/A	N/A	Access Aisle Location	N/A
	N/A	Parking Spot Width (in)	N/A		
	N/A	Parking Spot Length (in)	N/A		
	N/A	Van Accessible?	Yes		
	Yes	Curb Ramp?	Yes		
	N/A	Identification Sign?	Yes		
	N/A	Sign Height (in)	85.0		
	N/A	Vertical Clearance	N/A		
	N/A	Parking Meter?	No		
	N/A	Parking Meter Height (in)	N/A		
	N/A	Meter Operable Parts?	N/A		
	N/A	Meter Clear Space?	N/A		
	N/A	Meter Clear Space Slope (%)	N/A		
	N/A	Meter Clear Space XSlope (%)	N/A		
	N/A	Meter Forward Reach?	N/A		
	N/A	Meter Forward Reach (in)	N/A		
	N/A	Meter Parallel Reach?	N/A		
	N/A	Meter Parallel Reach (in)	N/A

N/A	Parking Space/Access Aisle Slopes (%)							
	C Slope (%)	2.7	D Slope (%)	2.8	I Slope (%)	1.4	L Slope (%)	N/A
	B Slope (%)	2.8	E Slope (%)	2.7	H Slope (%)	3.1	K Slope (%)	N/A
	A Slope (%)	3.0	F Slope (%)	3.0	G Slope (%)	1.9	J Slope (%)	N/A
N/A	Parking Space/Access Aisle XSlopes (%)							
	C XSlope (%)	1.9	D XSlope (%)	2.3	I XSlope (%)	2.8	L XSlope (%)	N/A
	B XSlope (%)	1.8	E XSlope (%)	2.6	H XSlope (%)	3.4	K XSlope (%)	N/A
	A XSlope (%)	1.9	F XSlope (%)	2.8	G XSlope (%)	1.2	J XSlope (%)	N/A

Advise relocating to an area with maximum 2% slopes
